FIELD CASE STUDY OF MEDIUM-VOLTAGE CABLE ACCESSORIES WITH PARTIAL DISCHARGES IN THE HYDRO-QUEBEC UNDERGROUND DISTRIBUTION NETWORK

Daniel FOURNIER
Hydro-Québec Distribution-Canada
fournier.daniel.3@hydro.qc.ca

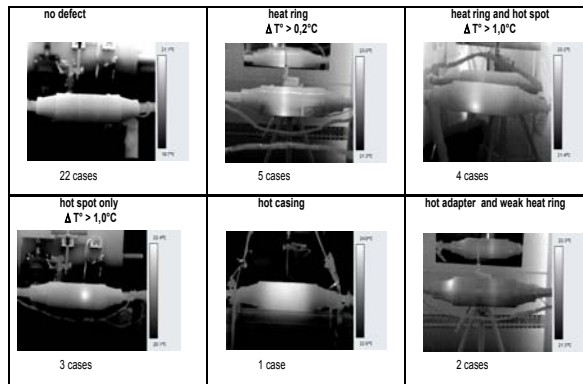
Figure 2. Infrared images (at $1 U_0$, no current load) of 37 type A straight joints removed from the field. Classification of dielectric hotspot defects according to their shape and ΔT .

All seven cases in the red part of Table 1 failed to pass either the AC or the DC withstand tests. In fact, dielectric breakdown occurred at fairly low values (21-23 kV AC and 30-48 kV DC). Live infrared recordings and dissections showed that all breakdowns occurred exactly at the hottest dielectric spot observed on joints (see Fig. 3). Moreover, these recordings showed that the same dielectric hotspots observed at $1 U_0$ were also present during DC withstand tests. They also showed that the ΔT of dielectric hotspots was directly proportional to the voltage during the HV withstand tests. These observations lead to the conclusion that joint defects consist in a direct conduction path through the rubber insulation, as confirmed by the specific PD pattern associated with these defects (see Fig. 4). Therefore, AC or DC dielectric breakdown occurred as the result of excessive heat (ohmic losses) in the conduction path.

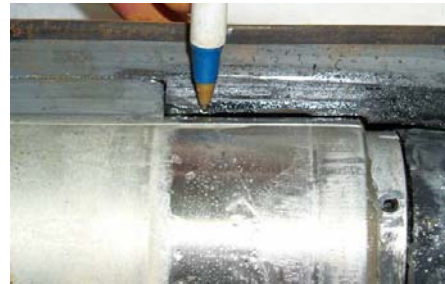
Figure 3. Dissection of a type A joint. The inner Al sleeve is sometimes not connected to the cable connector, which is at high voltage. Note also that the inner semi-conducting material (at the tip of the pen) is not in close contact with the sleeve. Dielectric breakdown occurred through the insulation, to the left of the pen.

Three joints with PDs did not fail during the HV withstand tests. According to our x-ray images and dissections (see Fig. 3), the PDs in these cases occurred between the inner Al sleeve, which is at an unknown potential, and the crimped cable connector at HV potential. Moreover, PD activity for these cases occurred in the first and third quadrants. They did not show the special pattern (see Fig. 4) associated with "direct conduction" defects. None had any dielectric hotspots or rings although one case had a specific heat pattern (hot casing).

X-ray images and dissections were very helpful in finding an answer. They showed that every joint with a defect had air gaps between the inner semiconductor (EPDM rubber doped with carbon black) and the Al sleeve. We also observed that, in some cases, Al sleeves were not in contact with the cable connector, i.e. they were not at the HV potential. This situation is due to a time- and heat-related mechanical relaxation mechanism affecting joint semiconductor and EPDM materials [3-4]. Dissections also showed us that, in some cases, corrosion of Al sleeves had seriously deteriorated the sleeve/connector contact.

We conclude from the above observations that mechanical relaxation of materials and corrosion of the Al sleeves prevent good contact of the semiconductor with the HV parts inside some aged (~23 years in service) type A joints. Thus the semiconductor cannot smooth out the equipotential lines, probably generating high electrical stress at some points (see Fig. 3) and, eventually, leakage currents with ohmic losses through the insulation. The final degradation step is characterized by the presence of PD activity.

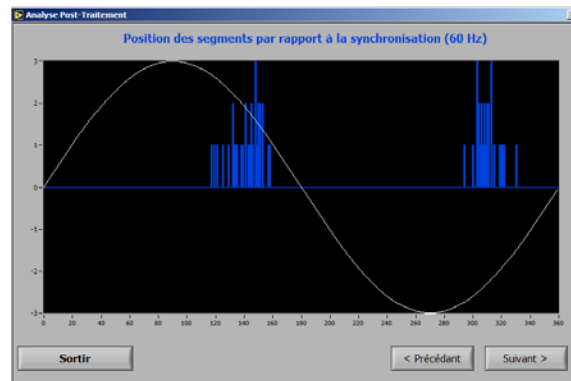
Figure 4. Phase resolved detection for the defective cable joints shows that PD activity shifts by 90°. Most PD pulses occurred in the 2nd and 4th quadrants [1].

Finally, Table 1 shows that joint breakdown occurred only in the presence of 1) a dielectric hotspot whose $\Delta T \geq 1.2^\circ\text{C}$ and 2) PDs that occur mostly in the second and fourth 60-Hz quadrants.
