## EXPERIENCE PERFORMING INFRARED THERMOGRAPHY IN THE MAINTENANCE OF A DISTRIBUTION UTILITY

José MARTÍNEZ  
Edenor S.A. – Argentina  
jmartinez@edenor.com

### ABSTRACT

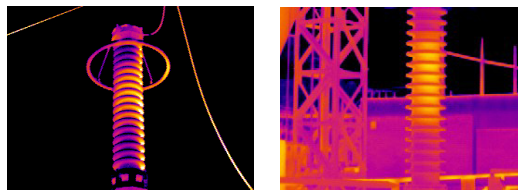
These enclosed points in some cases even when out of service, do not allow a maintenance routine and/or an effective check of its true state. It is the case of HV surge arresters, where slight thermal differences of around  $3^{\circ}\text{C}$  detected between different component units of a phase and those belonging to the other phases, made it possible to identify important internal damages in the affected arresters, originated by entry of moisture due to sealing defects between flanges and the external insulator, causing tracking

and discharges that affected non-linear resistors, capacitors and gap elements (Fig. 1). As a result, similar models of this equipment were carefully scanned, leading to settle the need of replacing several of them.

Fig. 1 - Thermal anomalies in HV surge arresters.

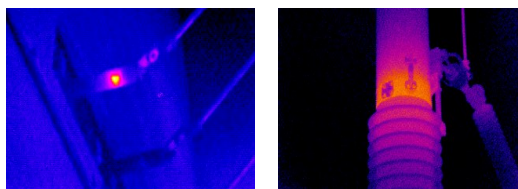
In wall-bushing current transformers, internal anomalies for overheating were also found, just as in oil HV circuit-breakers, where thermal differences of around  $10^{\circ}\text{C}$  between a pole of a phase and the other poles allowed the detection of anomalies caused by an abnormally high resistance of contact between their fixed and moving main contacts (Fig. 2).

Fig. 2 - Thermal anomalies in current transformers and HV circuit-breakers.

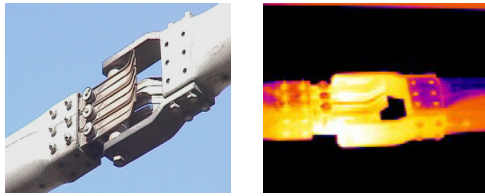
Besides, an important number of thermal anomalies appears in disconnectors contacts (45%), from mainly of defected contacts by deformations, deficient pressure of contact, incorrect alignment of arms and dirtiness (Fig. 4).

Fig. 4 - Disconnector contact and Infrared Thermography of thermal anomaly detected on this item.
