CORROSION – KEY FACTOR OF DURABILITY AND SAFETY IN THE OPERATION OF THE DISTRIBUTION POWER NETWORKS

This paper presents the results of an in situ campaign carried on some regions of Romania in order to assess the stage of degradation by corrosion of buried components belonging to power systems. Two issues have been addressed: the first refers to the metallic armor of MV underground cables installed in a variety of soils, in locations with and without DC stray currents; the second one refers to earthing systems located in power substations. The corrosion state was visually analyzed for all studied cables in the zones of contained faults and for the metal conductors of the earthing system. For underground cables, the galvanic continuity of the metallic armors and the insulation resistance between armor and soil, respectively between armor and live conductor were also determined.

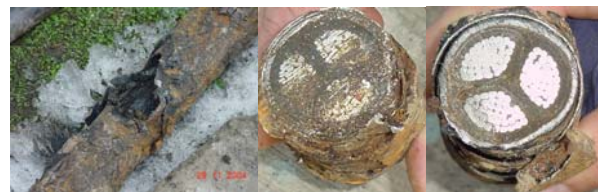
Figure 1. Degradation and electric failure of a underground three-phase cable due to the corrosion of the metallic shield made of steel strips

The analysis of images in Figure 1 indicates that the electric failure (disruptive breakdown) of the cable occurred in a sector where the metallic shield, made of steel strips, is very corroded; this can be explained by the diminution of the insulation electric strength as a result of ionic components, their infiltration in the volume of insulator by electrochemical treeing [7] and formation of forerunner centers for the electric treeing [8].

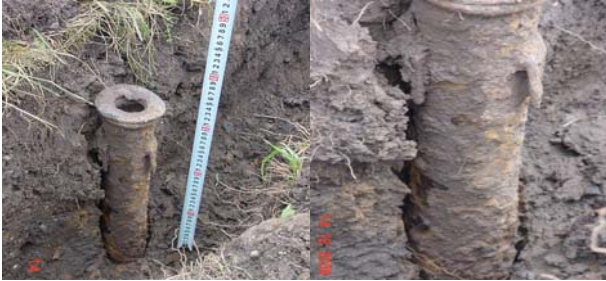
Figure 2. Corroded elements of the earthing system installed in 1965 to Cluj HV/MV substation

All these pictures show that both earth electrodes and metallic armors of underground cables are extremely corroded. For underground galvanized steel strips, the analysis of the chemical reactions determining the corrosion of Zn – Fe combination, and of related standard potentials shows that steel corrosion (of both earth electrodes and cable armors connected to earthing network) is theoretically possible only after the complete chemical stripping of the zinc coating. However, the pictures presented in Figure 3 show that metallic stripes still present, in some zones, small areas covered by zinc; this fact can be explained by the reversal of the Fe/Zn system polarity [11] in environments with oxygen that produces a faster Fe corrosion.

For the studied system, the total current through the earthing network changed between 82.4 A (measurements between 9⁰⁰ and 12⁰⁰ a.m.) and 69.4 A (measurements between 11⁰⁰ and 12⁰⁰ p.m.), i.e. a polarization current density of 1.75 – 2 A/m² (the total area of buried metallic structure was considered 40 m²). Experimental results presented in [12] for OL37 steel buried in underground water show that an acceleration of corrosion process begins at about 0.3 A/m²; higher values assessed for the studied structure can explain the advanced degradation stage of the metallic buried components.

The practical determination of corrosion potential on the earth electrodes installed in 1965 have indicated values in the range + 0,02 to – 0,31 V_{Cu/CuSO₄}; the positive values have been all assessed in the south-eastern part of the substation, closed to the tramway railway (about 300 m). These differences, depending on the relative distance to the tramway railway, may suggest that, besides the AC polarization, the DC stray currents providing from the tramway network have also contributed to the corrosion of studied earthing system [14].

compulsory the re-evaluation of the earthing networks design and technology, i.e. the replacement of the zinc-coated steel by other electrochemical inert materials, with a reduced rate of corrosion and electrolytic stripping.

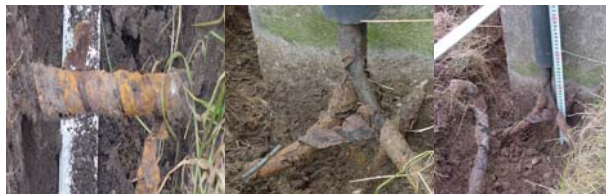
Figure 3. Corroded armors of control and signal cables

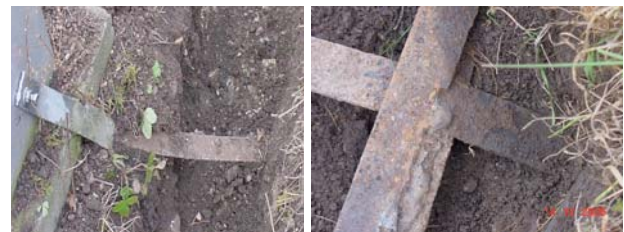
It is important to mention that the tramway network of Cluj-Napoca was operated since 1986, i.e. about 20 years after the installation of the studied earthing network, so we can conclude that till 1986 the corrosion rate was slower than nowadays. In order to assess the existing corrosion rate, the state of galvanized steel strips installed in 2001 during the partial overhauling was studied; values ranging between – 0.12 and – 0.34 V_{Cu/CuSO₄} of the corrosion potential were determined for these newly electrodes. Figure 4 shows the stage of degradation for horizontal electrodes located in the south-eastern part of the substation (zone affected by the tramway railway): the zinc coating is already quite severely corroded and this fact certifies the existence of a high corrosion rate due to the polarization phenomena produced by the simultaneous presence of AC unbalance currents and DC stray currents [3], [12 ÷14].

Figure 4. Degradation by corrosion of horizontal electrodes installed in 2001

The analysis of the galvanized steel strips installed in 2001 during partial overhauling shows that these elements, regardless of the short operating life, are already affected by the corrosion process, and the zinc is stripped on some elements. This fact indicates that nowadays corrosion rate is very high due to the polarization phenomena produced by the simultaneous presence of AC unbalance currents and DC stray currents.

Taking into account the above mentioned aspects and the existing technology of earthing networks we can conclude that, in nowadays conditions regarding the electromagnetic pollution of soil with AC and DC stray currents, the durability of earthing systems is quite limited. From the sustainable development point of view, in order to assure the safe operation of power systems, we consider as compulsory re-evaluation of the earthing networks design and technology, i.e. the replacement of the zinc-coated steel by other electrochemical inert materials, with a reduced rate of corrosion and electrolytic stripping [2].
