POSSIBILITIES AND REMEDIAL MEASURES TO REDUCE LIGHTNING-CAUSED OUTAGES IN A DISTRIBUTION NETWORK

The paper presents a project, which aims to increase reliability in an existing overhead distribution network by taking measures addressing lightning and grounding issues. Due to the fault statistic, a single overhead line was identified as a main reason for the lightning-caused outages in this area. Possibilities to reduce the lightning-caused outages are summarized and the measures taken in this distribution network are described. All considerations took the special geographical situation (2300 meter), the grounding resistance and the local lightning activities into account. Numerical calculations are performed to assess the application of surge arrestors regarding the transient voltage stress for the isolators. According to the simulation results, a strategy is laid out to implement surge arrestors in this overhead line. In this paper, the project steps and the results of the 3-years field-experience is discussed and presented.

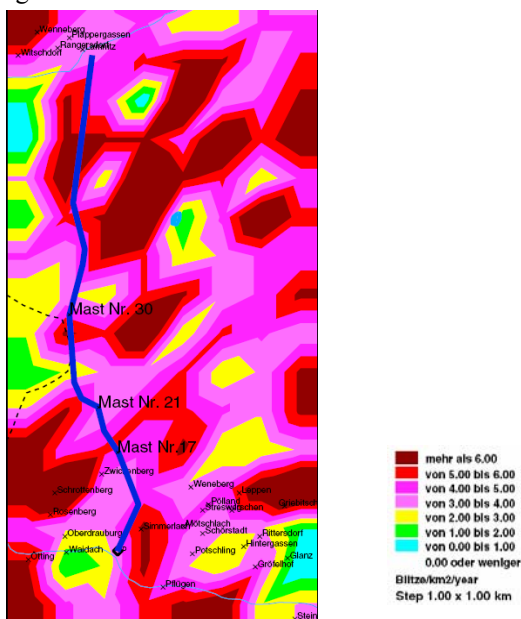
Figure 2: Lightning density in the area of the overhead line in the year 2006

In the area of the 110kV distribution line the number of atmospheric discharges to the line conductors and/or into the surrounding environment is higher than the average value of Austria, which is confirmed by the data of ALDIS (Austrian Lightning Detection & Information System). The average location accuracy for all detected lightning strokes in Austria can be denoted with better than 1km (ALDIS). The lightning density in the region of the overhead line is in a range from 3 up to more than 6 lightning strikes per km² and year. Of course these values can vary from year to year, but they are always higher than the average values of this region.

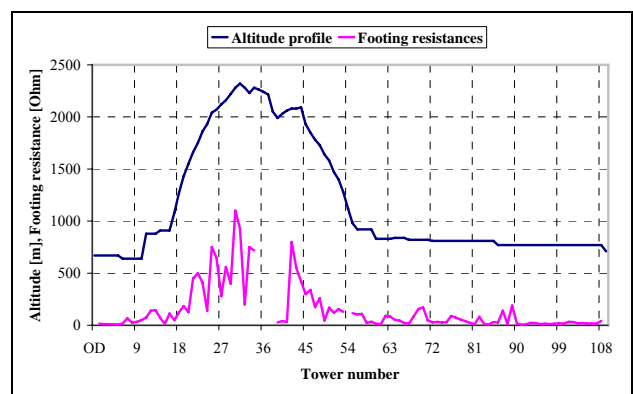
Figure 3: Altitude profile and footing resistances along the overhead line

As mentioned before, nearly one third of the 110kV overhead line runs in a high alpine region with rocky soil and bad tower earthing conditions. The values of the footing resistances are in a range of approx. 200 to 1200Ω. The footing resistances between tower no. 34 and 39 are not documented.

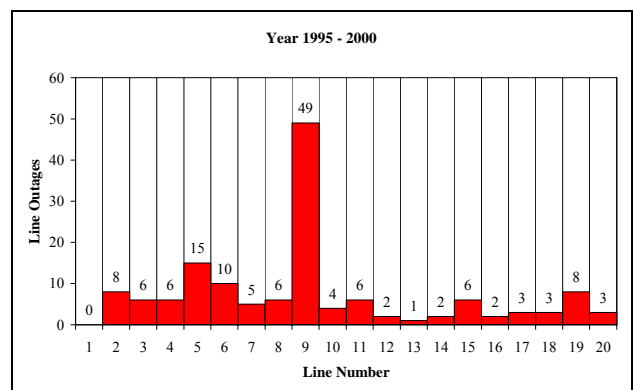
Figure 4: Line outages in the 110kV distribution network 1995 – 2000

As shown in figure 4, the number of line outages in the 110kV distribution network of the KELAG is in average lower than 2 outages per year. One single 110kV overhead line has 49 outages in a time span of 5 years and therefore approx. 5 to 10 times higher than the average value of the outages in the system.

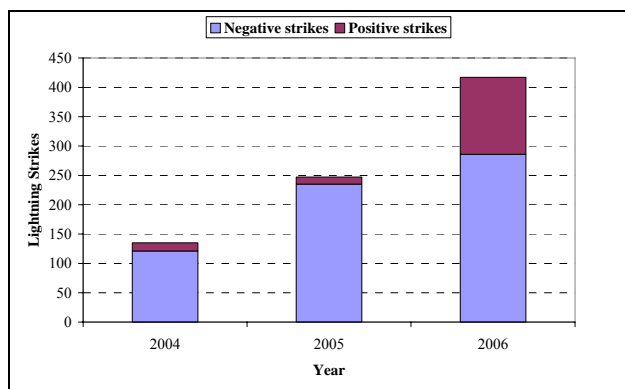
Figure 6: Number of lightning strikes in the line corridor in the three years observation period (2004 – 2006)

ALDIS detected in this three years observation period from 2004 to 2006 a total number of 799 lightning strikes with a total number of 1463 flashes. The average value of the amplitude of the detected strikes was approx. 15kA. As shown in figure 6 most of the lightning strikes are with negative polarity. In the year 2004 90% and in the year 2005 95% of all lightning strikes had a negative polarity, which corresponds to the well known polarity distribution. In the year 2006 an uncommon high number (31%) of positive discharges were registered in this line corridor.

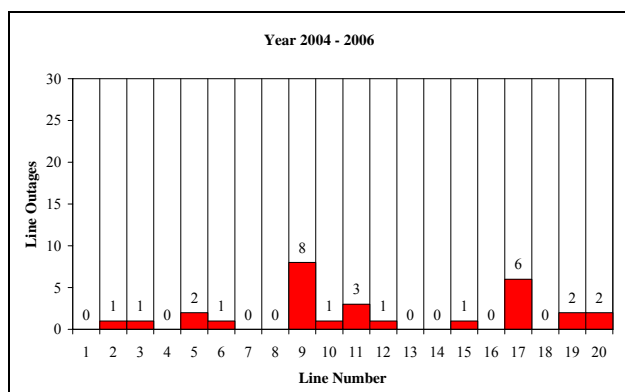
Figure 7: Line outages in the 110kV distribution network 2004 – 2006

A total number of 8 2- and 3-phase faults were registered, none of them within the rearranged section of the line. Further, a total number of 8 temporary phase-to-ground faults could be correlated with lightning activity in the line corridor. Therefore, the lightning activity has lead to earth faults and not to 2- and 3-phase faults. Outside the rearranged line section the number of failures is comparable with the failure rate between 1995 – 2000.
