STUDY AND INVESTIGATION OF MEDIUM VOLTAGE POLLUTED INSULATORS IN ALEXANDRIA DISTRIBUTION GRID

Prof. Ahmed HOSSAM-ELDIN
Electrical Eng. Dept. , Alexandria Univ. - Egypt
a.hossamudn@gmail.com

Ibrahim MADI Sami SHARAF
Alexandria Electricity Distribution Company - Egypt

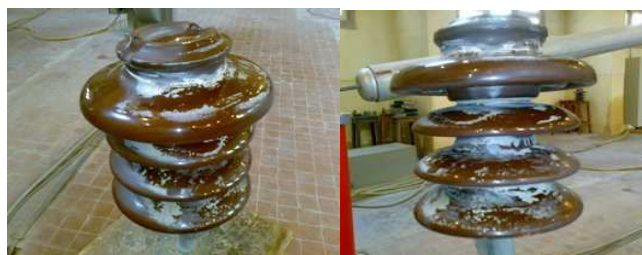
Some of the insulators have combined contamination of the two above types. Fig (1)shows polluted insulators.

Fig.(1). Polluted Insulators
