## Use and Problems of On-line PD Measurement Technology on Switchgears in Guangzhou Distribution System

### Abstract:

*On-line PD measurement technology is a useful method to find out insulation defect preventing from power out. A kind of on-line PD measurement technology Ultra TEV plus+ and PDM03 has been introduced in this paper. Principle of the technology has been presented simply. And use in Guangzhou district is also summerized. It is essential to investigate how the PD signals develop and acquire fault presentiment ways, and so, the relationship between PD magnitude and factors such as circumstance temperature and relative humidity should be confirmed. Moreover, PD in different phases also needs to be researched. And basing on works above, early fault presentiment ways suited for practice should be put forward.*

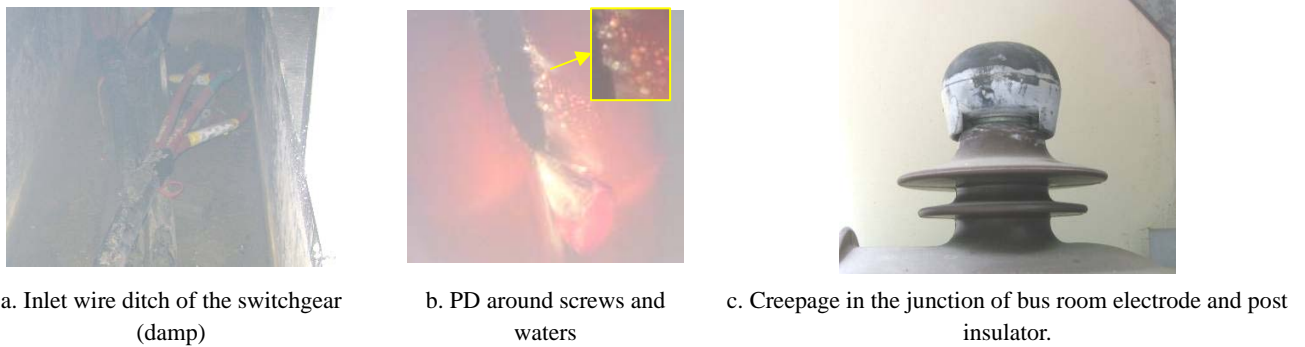
Afterwards, internal situation of the new switchgear was detected. It was found that inlet wire ditch of the switchgear was damp .There were screws and a mass of waters around trident mouth of electric wire in inlet wire room, as shown in figure1. It is indicated that partial discharge occurred distortion that caused corona discharge due to the existence of screws. A mass of waters would be adsorbed because of the effect of electrostatic field around the screws, which would cause corona discharge, too. The local area would be white finally. There was obvious corrosion in the junction of

bus room electrode and post insulator.

Fig1 the detected switchgear inside the electric room

In 27 June 2009, the switchgear was repaired. Then the working state of the switchgear was normal, and it functions normally.

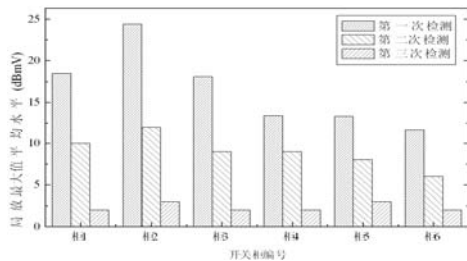
Maximum average values of partial discharge on each side

of the switchgear from three tests are shown as figure3. In 2 February 2010, 12 February 2010 and 29 March 2010, the amplitude was 20dB, 10dB and 3dB in the result of ultrasonic test. In 29 March 2010, the results showed partial discharge was disappeared temporarily

Fig3 Maximum average values of partial discharge on each side of the switchgear

For case three, the amplitude was 20dB, 10dB and 3dB in the result of ultrasonic test three times. The switchgear should be repaired according to the first detection, while the switchgear was normal that did not need any reparation according to the third detection. Obviously, single threshold standard is not suitable for this situation. Instead, the development trend of amplitude was more significant for the operation of switchgear. During the test, temperature of electric room was 11.5°C, 16°C and 23.6°C respectively, and relative humidity of electric room was 89%, 69% and 46.4% respectively, the relationship with amplitude in the result of ultrasonic test was showed as figure6. From figure6, the indicator value of partial discharge increased positively with temperature and negatively with relative humidity. Intensity of partial discharge was changed with external environment. According to operation experience, the partial discharge was possibly corona or creepage on surface of switchgear. And it is the most common in semi-insulating switchgear.

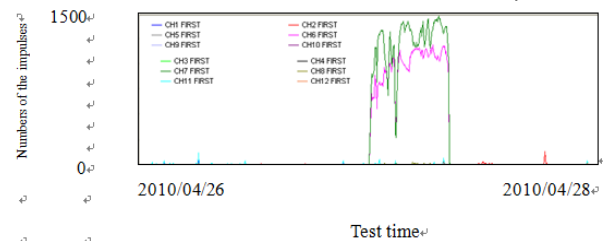
In 5 April 2010, working state of the switchgear in the same electric room was detected for the third time. The amplitude was 19dB in the result of radio waves on ground test; the amplitude was less than 3dB in the result of ultrasonic test. In 26 April 2010, working state of the switchgear in the same electric room was detected for the fourth time. Paradoxical discharge was detected and located by using PDM03. Detected time continued for about 3 days, results are shown as figure4 and figure5. The green curve and the red curve are the amplitude of two of different sides of the switchgear. As a matter of judgment experience, partial discharge occurred close to number6 channel and number7 channel on certain period of time in three days. And it is intermittent discharge.

Fig4 the relationship between numbers of the impulses and test time

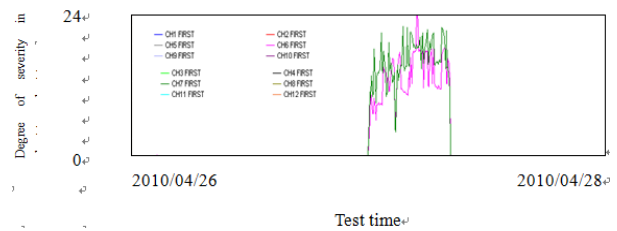
Fig5 the relationship between degree of severity in short-term and test time

For case four, the amplitude was 29dB, 30dB and 19dB in the result of radio waves on ground test three times. Partial discharge may exist in switchgear according to the first detection and the second detection, while the switchgear was normal that did not need any reparation according to the third detection. Obviously, single threshold standard is

not suitable for this situation, too. Instead, the development trend of amplitude was more significant for the operation of switchgear.

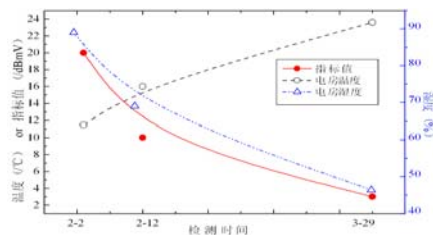
Fig6 the relationships between circumstance temperature (relative humidity)

and amplitude in the result of ultrasonic test
