INFRARED THERMOGRAPHY AND DISTRIBUTION SYSTEM MAINTENANCE IN ALEXANDRIA ELECTRICITY DISTRIBUTION COMPANY

This paper describes results of the power line inspections at Alexandria Electricity Distribution Company using a thermal image camera and corrective actions taken for discrepancies found during the inspections. They can be categorized into two case studies as follows:

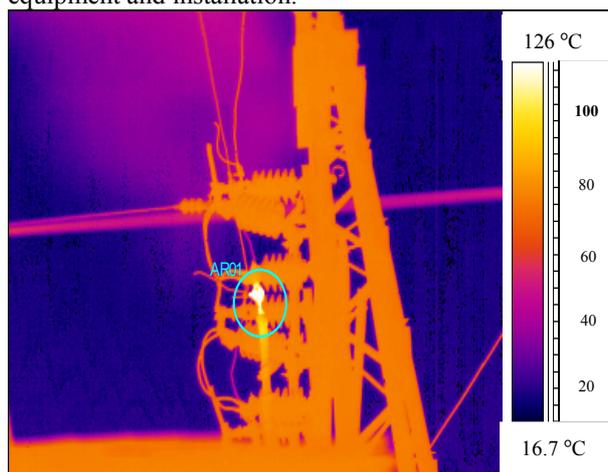
A high-temperature spot is found at the connector of phase-T conductor at the jumper of the riser pole is shown in figure 1. This means that phase-T connector has high temperature due to using inappropriate equipment and tools; use of a machine bolt instead of hexagon bolt without a spring ring has caused a bad electrical connection so that it is proposed to make a replacement using the appropriate equipment and installation.

Fig.1 shows the damaged connector of phase T at EL HARES-ABIS O.H.T.L.

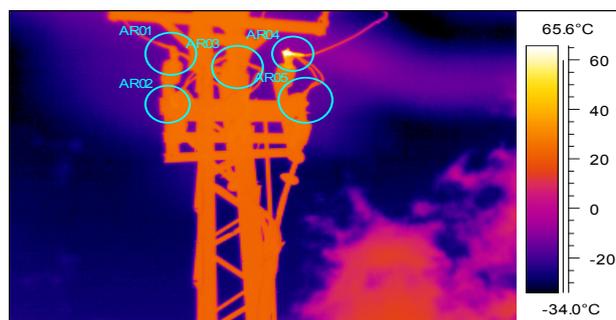
A high-temperature spot is detected at the top conductor in figure 2 which can be caused by a loose

connection.

Fig.2 shows a color-infrared image resulted from a thermal image camera at MARAKIA 2 O.H.T.L.

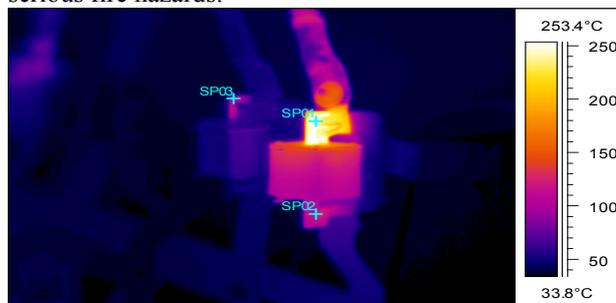
This case study shows the looseness in fuse connection as shown in figure 3. Infrared camera detects effectively loose electrical connections which generate heat and can pose serious fire hazards.

Fig.3 shows an increase in temperature in fuse connection due to the looseness in connections at T.P 784-B.

This hot spot can be prevented by keeping electrical connections tight and torque to recommended values. Also, bimetallic must be used in order to prevent looseness in connections.

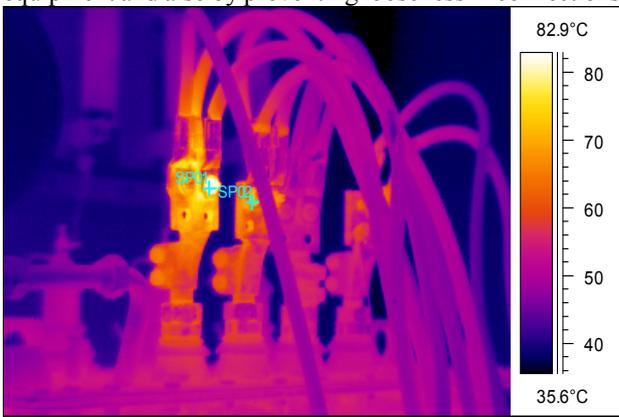
This case study shows transformer insulator bushing heating which breakdown over time due to its high temperature. If it is not replaced in sufficient time, catastrophic failures can develop. Thermography can locate overheating transformer bushings to provide early warning so that repairs can be planned before failure which is shown in figure 4. This deficiency can be avoided by scheduled cleaning the equipment and also by preventing looseness in connections.

Fig. 4 shows an increase in temperature in transformer bushing due to dust and dirt accumulation at T.P 867-B.

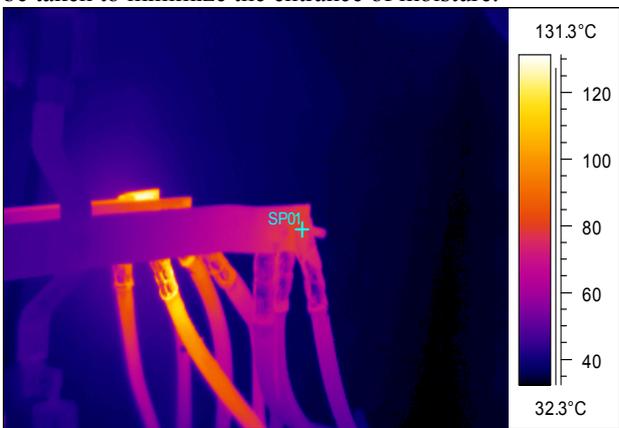
Thermography can locate overheating transformer secondary line connections as shown in figure 5. This overheating type may be due to the presence of moisture which can cause connection failure, so precautions should be taken to minimize the entrance of moisture.

Fig. 5 shows an increase in temperature in transformer secondary line connections due to the presence of moisture at T.P 498-B.

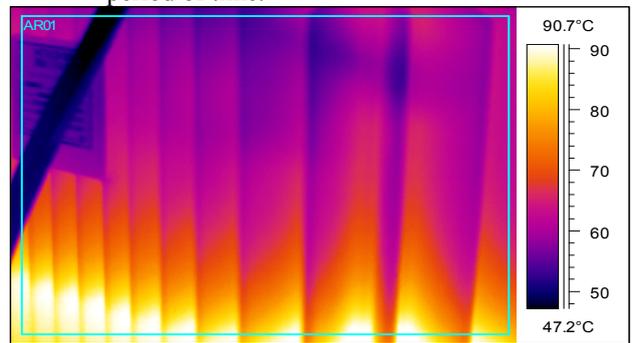
Thermal image camera can also identify overheating components such as transformers as shown in figure 6. Transformer overheating increases transformer losses , weakened the insulation and may result in reducing transformer life. The principal reasons for transformer overheating are classified as follows:

- Excessive transformer loading.
- Excess current in the neutral of the transformer.
- Problems in the cooling system.
- High harmonic content in the power supply.
- Sustained overvoltage which exists for a long period of time.

Fig. 6 shows the transformer overheating which reduce the transformer life at T.P 695-B.

Since transformers are a critical and expensive component of the power system so that it must be protected against faults and overloads. The type of protection used should minimize the time of disconnection for faults within the transformer and to reduce the risk of catastrophic failure to simplify eventual repair. Any extended operation of the transformer under abnormal condition such as faults or overloads compromises the life of the transformer, which means adequate protection should be provided for quicker isolation of the transformer under such conditions.

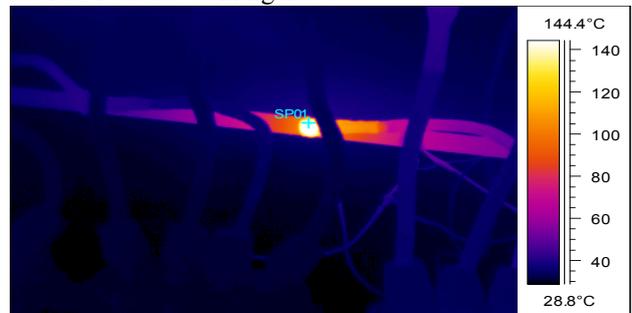
A large ground current which may trip the protective devices is detected in figure 7.

Fig. 7 shows a large ground current due to the unbalanced loads between the three phases R,S,T at T.P 322-B.

This is considered as a sign of the unbalanced loads between the three phases R, S, T. This phenomenon is very dangerous since the system power quality is affected. For example, the unbalanced loading causes unbalanced voltages even the voltage at source is balanced. Lower, higher, or unbalanced voltage can reduce efficiency and may damage appliances. Furthermore, this phenomenon must be prevented by balancing loads in distribution systems.
