SERVICE EXPERIENCES IN DENMARK WITH MIXED MEDIUM VOLTAGE (MV) CABLE SYSTEMS CONSISTING OF BOTH XLPE AND PILC CABLES TECHNOLOGIES

Jens Zoëga Hansen
Danish Energy Association – DK
jzh@danskenergi.dk

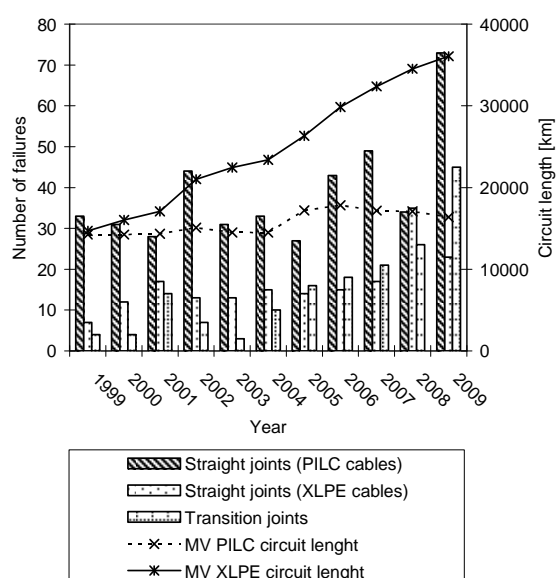
Figure 1: Number of failed MV cable joints between 1999 and 2009.

In Figure 1 is shown the number of failed joints per year in the period. Failed MV joints have been divided into three groups: PILC straight joints, XLPE straight joints and transition joints.

The database, unfortunately, does not contain information about the total number of a specific type of joint. It is therefore not possible to calculate a failure rate. Instead the total circuit lengths included in the database is shown. This information together with the number of failed joints gives an indication of the ratio in failure rates between different MV joints. The assumption is that the number of transition joints is significantly lower than the number of straight joints for PILC and XLPE cables. If the failure rates for XLPE straight joints and transition joints are approximately the same, it would then be expected that the number of failed XLPE straight joints should be significantly higher compared to the number of failed transition joints. According to Figure 1 this is not the case and it is therefore

concluded that the failure rate for transition joints must be significantly higher than for XLPE straight joints.

The number of failed PILC straight joints is significantly higher than both the number of failed transition joints and XLPE straight joints. This, at least, suggests that the failure rate for PILC straight joints is higher than for XLPE straight joints. It is more difficult to draw any conclusion about the difference between the failure rates for PILC straight joints and transition joints. It seems reasonable to assume that the number of PILC straight joints still is larger than the number of transition joints. However, failed PILC straight joints are expected to have been in service for much longer time than the bulk of the failed transition joints. This suggests that failures in transition joints are of a premature nature, i.e. they have failed relatively shortly after they have been put into service.

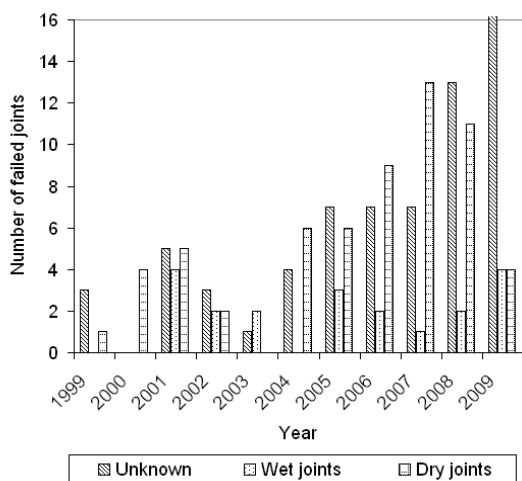
Figure 2: Distribution of failed transition joints regarding used technology.

Transition joints can be divided into two groups based on the used joint technology: Wet design and dry design. In wet design oil or a sealing compound is used as insulation. In dry design the PILC cable is sealed and the joint is more or less designed like an XLPE straight joint. The dry design is exclusively used today. A third group is introduced because it is not always reported in the database whether a failed transition joint is of wet or dry design. Figure 2 shows the distribution of failed transition joints with regards to the type of design used.

52 % of the failed joints have an unknown design. Of the 48 % where the type of design is known, 36 % are of the dry design, and only 12 % are of the wet design. This may indicate two things:

- 1) The failure rate for transition joints of the dry design is significantly higher than the failure rate for transition joints of the wet design
- 2) The number of installed transition joints of the dry design is significantly larger than the number of transition joints of the wet design

The explanation is most probably a combination of both items.

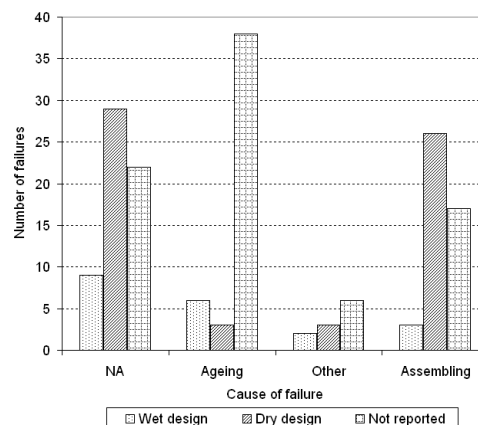
Figure 3: Cause of failure in transition joints.

When utilities report a failed transition joint they are also requested to report the cause of the failure. In Figure 3 is shown the causes of failed transition joints. Unfortunately, this information is not available for 37 % of the reported failures.

In the case of transition joints of the dry design, 43 % of the failures are due to the assembling process and the cause is unknown for 48 % of the failures (a larger share of these are therefore also expected to be caused by the assembling process). The high number of failures due to the assembling process is in support of the assumption that the bulk of the failed transition joints are premature. In the case where the type of transition joint is unknown the number of failures due to the assembling process is also high, about 20 %, but here ageing counts for the larger share of the failures, about 46 %.

Some of these transition joints will also be of the dry design. The high number of ageing related failures for wet design transition joints also indicates that these in general have been in service longer than transition joints of the dry design.

In the case of transition joints of the dry type design, more work needs to be done, also. The high number of failures in the case of particularly transition joints of the dry type design (which is exclusively used today) due to the assembling process is positive in the sense that it should be possible to reduce the number of these failures. This may be done by being more careful with the assembling process and by making sure that the technician who assembles the transition joint has the proper instruction and education. This, however, is only possible if the utilities examine the failed transition joints, so they can learn from experience what went wrong. Today a database that collects detailed information about the failure mechanism does not exist (only that the cause of failure is due to the assembling process is being stored), which at the moment makes it impossible to list typical failure mechanisms due to the assembling process. More work needs therefore also to be done with regards to failures in transition joints, so that proper action can be taken to avoid or a least reduce the number of these failures in the future.
