POLE-TOP FIRES RISK ASSESSMENT: A SOUTH AFRICAN PERSPECTIVE

ABSTRACT

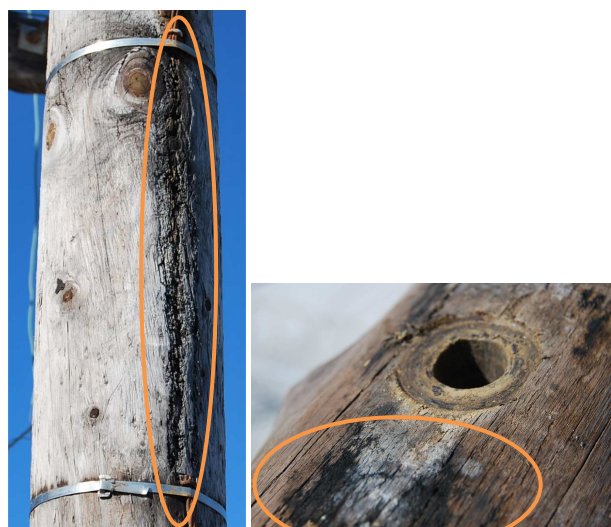
- No signs of tracking have thus far been found on any structure that was fully bonded and earthed;
- Tracking of various degrees of severity has been identified on the pole surface in all insulation coordination gaps – the most severe is shown in Fig 3a;
- The tracking in the gap of the structure with coated insulators was much less severe than that found on the adjacent structure with uncoated insulators;
- No tracking has thus far been found on the surface of any cross-arm at an insulator that was bonded (all insulators employed suitable conductive metal end fittings);

Fig 3: Tracking observed at KIPTS: a) in insulation coordination gap (left), b) at uncapped insulator without conductive plate (right)

- When a collector plate was not included with one uncapped post insulator for a short period, surface tracking was observed on the cross-arm at that insulator – this is shown in Fig 3b.
