## AGEING AND IMPROVEMENT OF LV UNDERGROUND EXTRUDED CABLES SYSTEMS

Laborelec – Belgium

### ABSTRACT

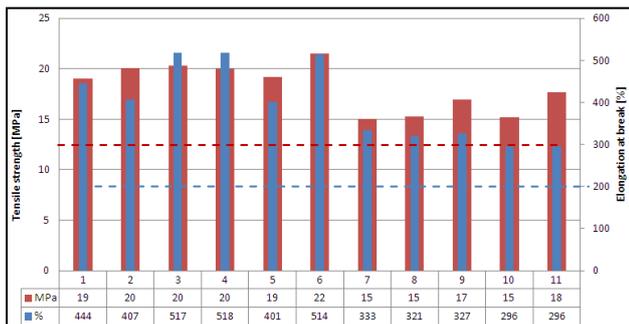
The decrease in elongation at break and tensile strength of the insulation were analyzed by performing tensile test on 11 faulty XLPE insulations. As shown in Fig. 7, the obtained values are higher than the requirements of CENELEC HD 603 for unaged XLPE insulation (min. 12,5 MPa and 200 % ).

Fig. 7 : Tensile test of 11 faulty insulations

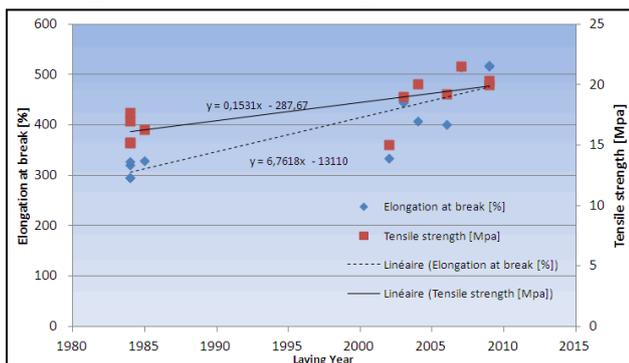
Fig. 8 : Elongation and tensile strength in function of laying year

The decrease in elongation and tensile strength are presented in Fig. 8 in function of the laying year. On the assumption that the decrease in mechanical properties is a linear function of time [1], we get two trend lines. According to the first trend line, cables laid before 1968 (45 years) have an elongation at break below the criterion standard (200%). According to the second trend line, cables laid before 1962 would have a tensile strength less than the standard criterion (12.5 MPa). More tests on older cables need to be carried out in order to confirm this ageing model.

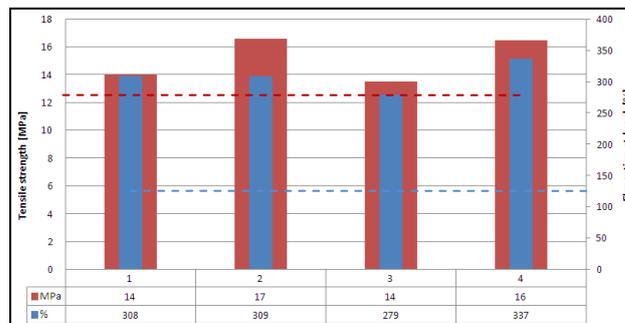
Tensile test were also performed on four faulty outer sheaths. The obtained values of tensile strength and elongation at break are higher than the requirement of the CENELEC HD 603 for PVC sheath (min. 12,5 MPa and 125 % ). The outer sheath in PVC contains phthalates to make the cable flexible. By varying the quantity of plasticizer, manufacturers can select precisely the degree of flexibility necessary to meet the mechanical requirements of the end product. Thermal ageing can lead to the evaporation

Fig. 9 : Tensile strength of faulty outer sheaths

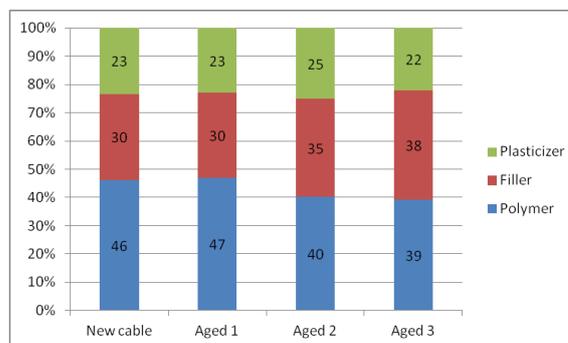
of plasticizers. The percentage of plasticizer has been measured by Pyrolysis GCMS on a new outer sheath and on aged outer sheaths from the field. The results of this analysis (Fig. 10) show that the remaining percent of plasticizer is still high enough to avoid cracking of the outer sheath at low temperatures (> 18 % [1]).

Fig. 10 : Percentage of polymer/plasticizer/filler

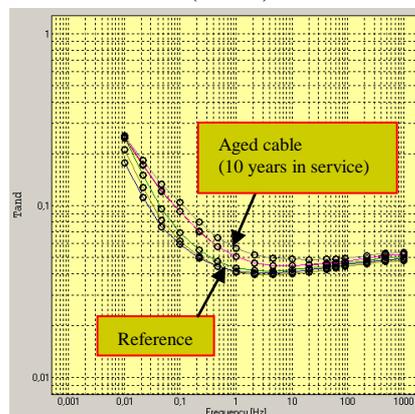
Most of the dielectric spectroscopy measurements on aged cables showed that the tangent delta increased over the years. Figure 11 compares the results obtained on an aged cable with those obtained on a reference from the cable library. In that case, Tan delta at 50 Hz (200V<sub>peak</sub>) increases from 0.04 to 0.0494 (+19%).

Fig. 11 : Increase in Tg delta after 10 years service

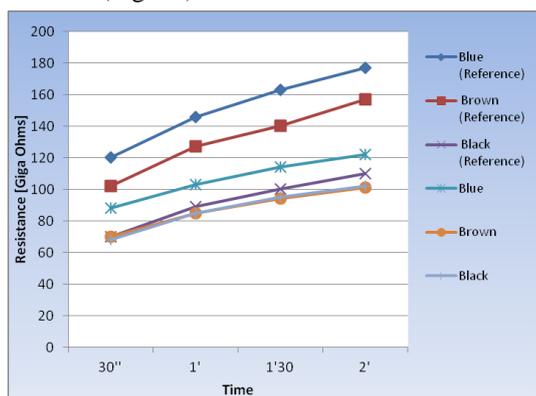
The insulation resistance tests carried out at 1 kV on both new and aged cables show similar results. The resistance of the phases of the aged cable is systematically lower than the resistance measured on the same core color from the reference (Fig. 12).

Fig. 12 : Decrease of the insulation resistance after 10 years service

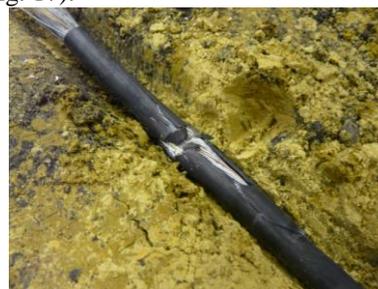
The impact tests at low temperature (-15 °C) have shown that PVC sheath with armour can be very sensitive to impacts (Fig. 17).

Fig. 17 : Impact test performed on LV cable with PVC outer sheath cooled at -15°C

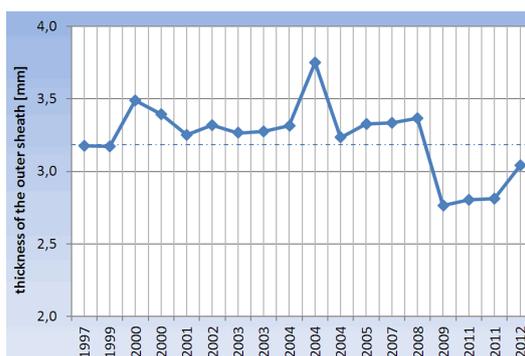
The outer sheath thickness of unaged cables fabricated between 1997 and 2011 was measured in accordance with the EN 60811-202. Since the revision of the NBN HD 603 in 2007, the nominal thickness of the outer sheath of the Belgian 4\*150 mm<sup>2</sup> 1 kV cable (EAXeVB) is 3 mm (instead of 3,2 mm) and the minimal value is 2,45 mm. The thickness measurements have shown a tendency of the cable manufacturers to decrease the average thickness in order to be close to the minimum value of 2,45 mm (Fig. 18). This decrease of the thickness could partially explain the increase of the breakdowns of newly installed cables.

Fig. 18 : Outer sheath thickness of new cables fabricated between 1997 and 2011

- Change the criterion of the water penetration test
- Require long-term tests with cables directly buried
- Require an impact test based on the test setup of the EN 50393
- Increase the average outer sheath thickness
- Require an LLDPE outer sheath and/or a more resistant PVC filler.
- Improve the quality of sector shape conductor by requiring additional tests to the EN 60228 that only gives requirements on resistance and tensile strength but no requirement on hardness or corrosion resistance.
