HARMONIC VOLTAGES AND LIGHTNING EQUIPMENT FLICKER CAUSED BY PUMPING STATION – MEASUREMENTS, ANALYSIS AND MITIGATION

ABSTRACT

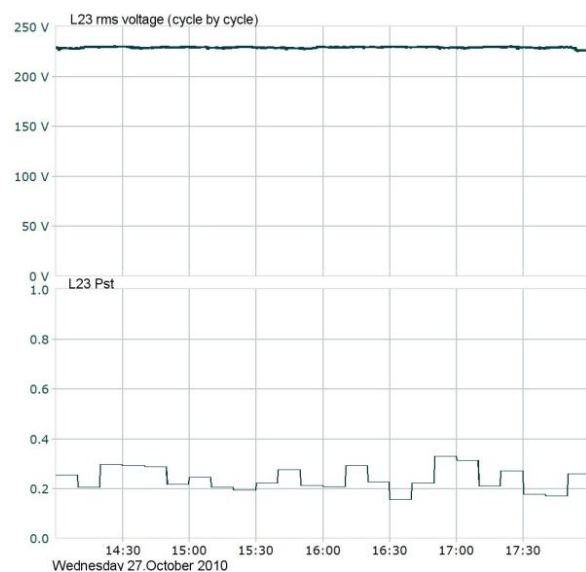
flicker levels and normal levels of rapid voltage changes. See Figure 1 for cycle by cycle rms variations of the voltage and the variation in Pst. The time range shown has low Pst values of only between 0.15 and 0.33. During these hours flicker was very visible.

Figure 1. Cycle by cycle rms voltage variations and variations in Pst for a time interval with very visible flicker.

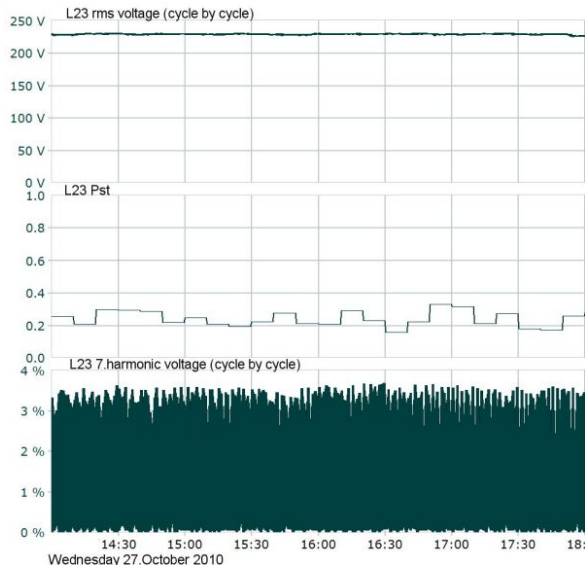
When cycle by cycle variations in harmonic voltages was investigated, THD was well below the limits given in the Norwegian regulations and EN50160. There was however significant levels of THD with an interesting pattern of variation. The by far largest contribution to the THD level was the 7.harmonic component in the voltage. In Figure 2 the 7.harmonic voltage component is shown together with the rms voltage variations and the Pst from Figure 1. The 7.harmonic limit value in both the Norwegian voltage quality regulation and the EN50160 is 5 % and in this case even the cycle by cycle levels of the 7.harmonic component were lower than 4 %. The 7.harmonic maximum levels were by itself not the problem. The experienced flicker problem is caused by some unexpected variations in the 7.harmonic voltage.

Figure 2. The 7.harmonic voltage component shown together with cycle by cycle rms voltage variations and variations in Pst for a time interval with very visible flicker.

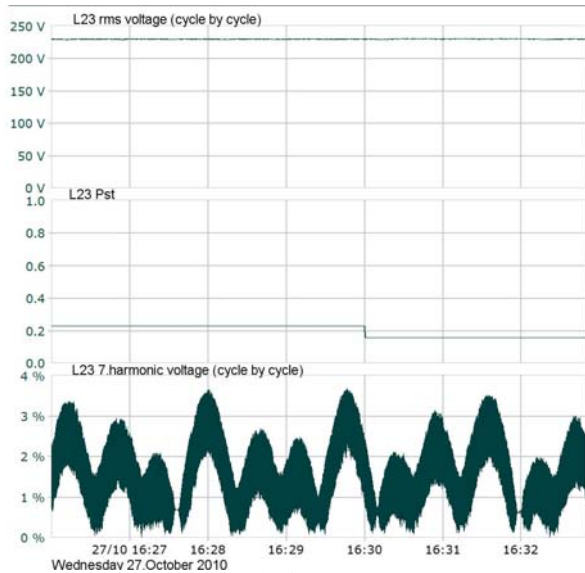
In Figure 3 the parameters in Figure 2 is zoomed in to view a shorter time range to reveal the interesting pattern in variation of the 7.harmonic component. These variations are of quite low frequencies (slow) and are not easily recognized by the human eye. In Figure 4 the rms voltage variations and Pst is removed and replaced by the voltage

Figure 3. The parameters in figure 2 zoomed in to view the interesting variation pattern of the 7.harmonic component.

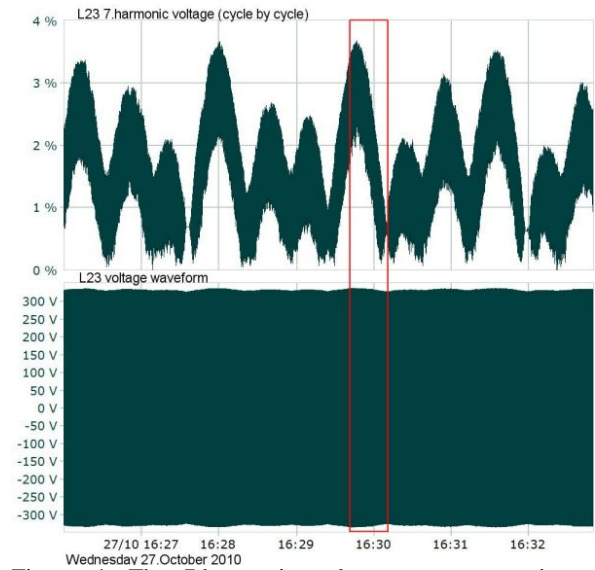
The wave shape envelope curve indicate that the 7.harmonic component significantly influence the wave shape peak values. However the variations visible in figure 4 is as stated previously so slow that they are not easily perceived as flicker. The red rectangle in Figure 4 indicates the time range for Figure 5. Figure 5 represents a shorter time range than figure 4 and shows in more detail how the 7.harmonic components impact on the voltage wave shape at a frequency more easily perceived as flicker. The most significant frequency component in terms of causing visible flicker is the approximately 2 Hz variations in the

Figure 4. The 7.harmonic voltage component shown together with the voltage wave shape (envelope curve). The red rectangle indicates the time range in figure 5.

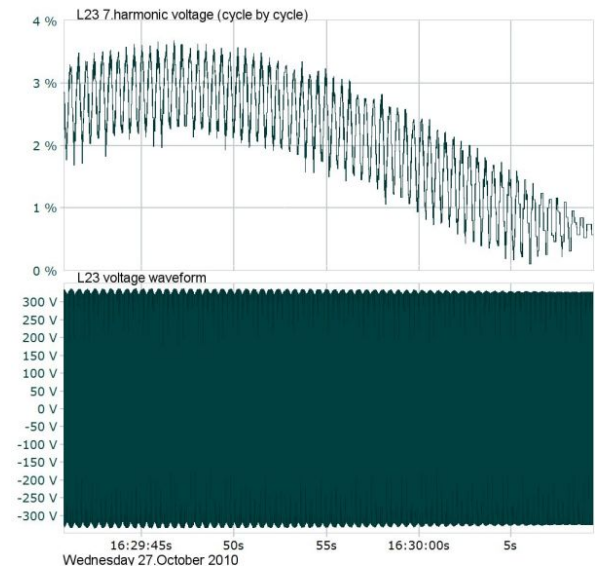
Figure 5. The 7.harmonic voltage component shown together with the voltage wave shape (only envelope curve visible). The time range equals to the red rectangle in Figure 4. The upper curve clearly shows the (approx.) 2 Hz variations in the 7.harmonic component.

- There is a pronounced approx. 2 Hz variation in the 7.harmonic component. This 2 Hz variation is also visible in the instantaneous value/curve of the fundamental line voltage (see e.g. Figure 5). The frequency of the 2 Hz variation is not constant during the measuring period (in the October 2012 measurements: approx. 4 hours): the frequency increases from approx. 1.9 Hz to approx. 2.1 Hz during this period.

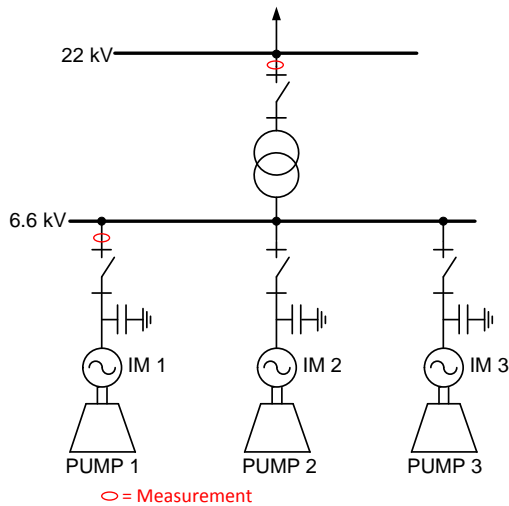
Figure 6. Single-line diagram of the pump station. The measuring points are depicted in the figure. Measurements performed with Elspec G4430 and G4500.

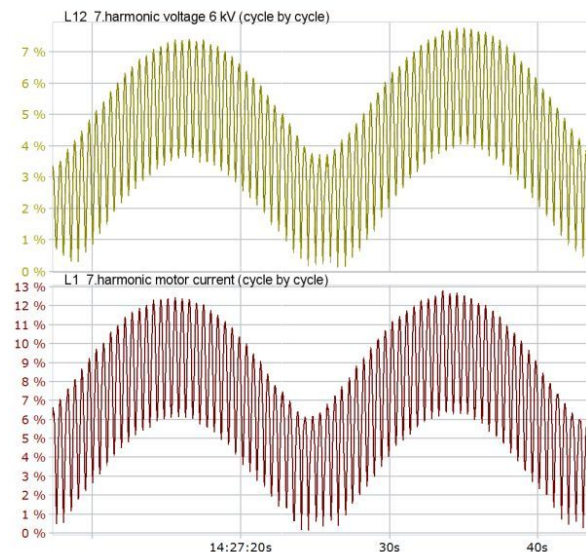
- There is a pronounced 7.harmonic component in both voltage and current both at 6.6 kV level and at 22 kV level. See Figure 7 for further details (relates to 6.6 kV level).
- The 7.harmonic component (in both voltage and

- The 7.harmonic component (in voltage and current) exhibits a pronounced low-frequency "wave-pattern" when 2 or 3 motors are in operation. The frequency of this "wave-phenomenon" is higher when three motors are in operation than when two motors are in operation. See Figures 3 and 4, and also Figure 7 for further details.

Figure 7. The 7. harmonic component in voltage and current, respectively, at 6.6 kV level. The 2-Hz variation is clearly visible. Three motors in operation at approx. rated power.

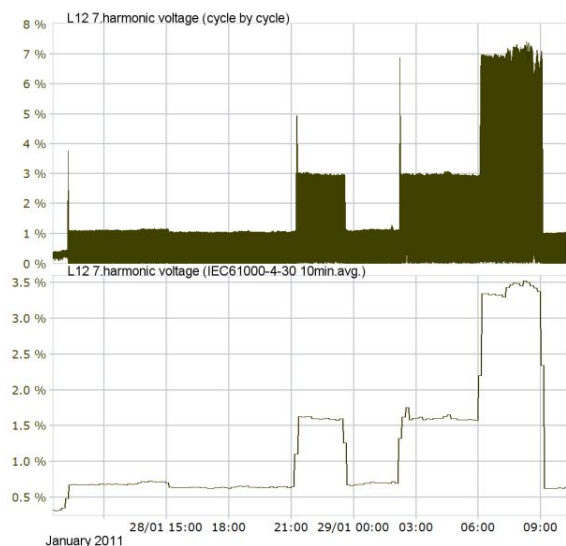
current) increase with number of motors that are in operation. See Figure 8 for further details. This also relates to the 7.harmonic in current of motor No. 1.

- The amplitude of this 2 Hz component, as identified via the 7.harmonic in the voltage at 6.6 kV level, increases with the number of motors in operation, from approx. 1 % for one motor via approx. 3 % for two motors to approx. 7 % for three motors in operation. See Figure 8 for further details.

Figure 8. Upper curve: The 7. harmonic component in voltage at 6.6 kV level for one motor (left part), two (middle) and three motors in operation. Lower curve: 10 min average of the 7.harmonic component, calculated according to IEC61000-4-30 [3].
