RESULTS FROM DANISH FAILURE STATISTICS FOR MEDIUM VOLTAGE XLPE CABLES

Jens Zoëga Hansen Danish Energy Association – Denmark jzh@danskenergi.dk

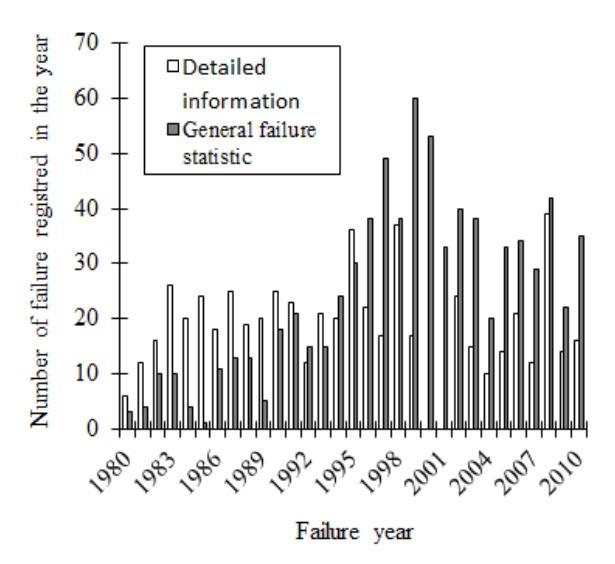
Figure 3: Registered ageing related failures on MV XLPE cables

Today detailed information has been collected for approximately 665 failed XLPE cables, where the failure has been ageing related. This does not account for all ageing related failures on XLPE cables. A comparison with the general failure statistic shows that 665 ageing related failures accounts for approximately 50% of the ageing related failures on XLPE cables since 1980, cf. figure 3. Particularly in the 1980ies not all DSOs who sent detailed information about XLPE cable failures participated in the general failure statistic. In the 1990ies and zeroes on the other hand there have been some difficulties in getting all DSOs to send detailed information about ageing related XLPE cable failures.

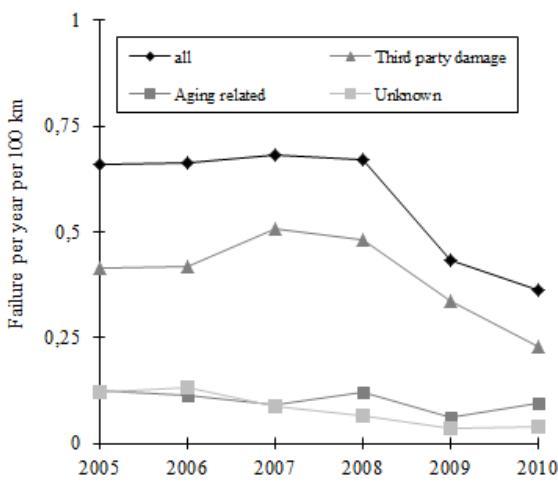
Figure 4: Failure rate for XLPE cables betweeen 2005 and 2010.

In figure 4 is shown the failure rate for XLPE cables in the periode 2005-2010. The significant drop in the failure rate between 2008 and 2009 can be explained from the failure rates due to third party damage, cf. figure 4. A similar shape of the failure rate due to third part damage has been found for MV PILC cables allthough the significant drop already took place between 2007 and 2008.

The very low failure rate for XLPE cables indicates that at the moment no significant problems with MV XLPE cables seem to exist. In comparison the overall failure rate for MV PILC cables in Denmark is close to 3 failures per year per 100 km. Nevertheless, because of the large share of cables with relatively short service times (less than 15-20 years), cf. figure 1, incipient problems with XLPE cables installed in the late 1970ies and the 1980ies could be hidden in the overall failure rate, which doesn't take service times of the failed cables and the age distribution of the XLPE cable population into account.

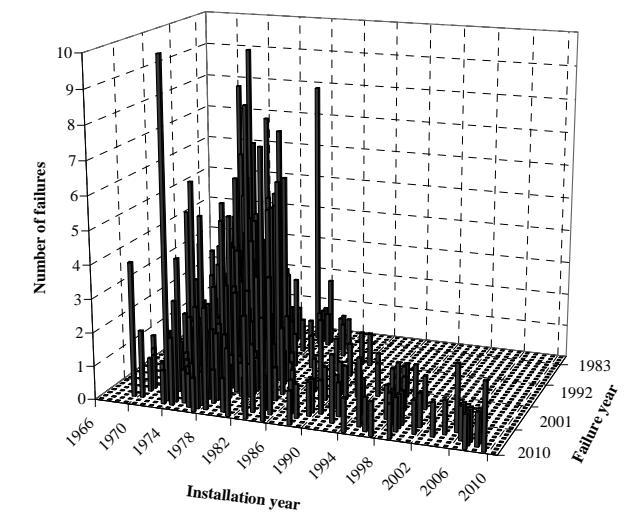
Figure 5: Registered failed cables with known installations year.

On figure 5 are shown all registered failed cables with known installation year (665 failed cables). It can be observed that most failed XLPE cables have been installed before 1980, which means that these cables are mostly steam-cured and not dry-cured according to table 1. Because of different service experiences with steam- and dry-cured cables it has been decided in the following treatment to differentiate between cables installed before 1980 and cables installed after 1980. In that case most steam-cured cables should be treated in the first mentioned group and most dry-cured in the latter.

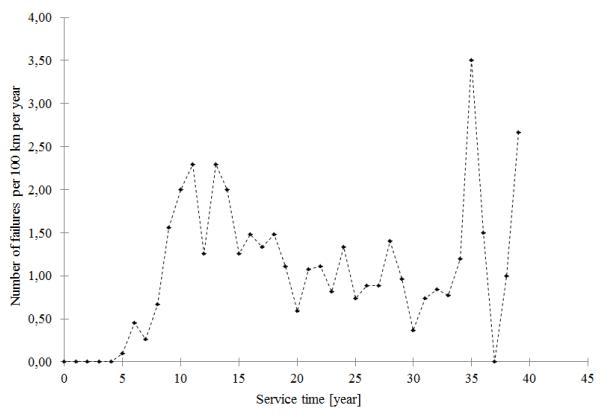
Figure 6: Failure rate as a function of service time for XLPE cables installed before 1980.

On figure 6 is shown the failure rate as a function of service time for MV XLPE cables installed before 1980. The assumption has been made that non of the cables have been taken out of service. This means in particular that the failure rate after 15 - 20 years is underestimated because most of the cables installed in the 1970ies are no longer in service. However, it has been well known for decades that these

cables have poor performance, so this is not important. What is important when comparing steam-cured with drycured XLPE cables is the first mentioned poor performance after only a few yaers of service.

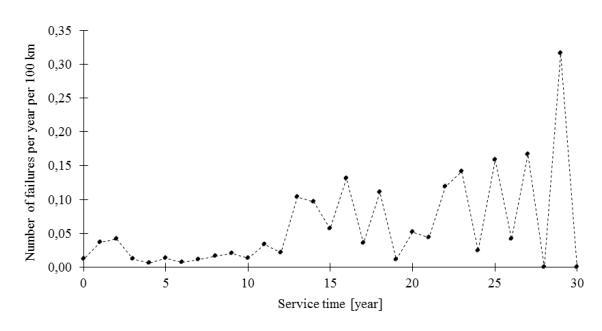
Figure 7: Failure rate as a function of service time for XLPE cables installed after 1980.

On figure 7 is shown the failure rate as a function of service time for cables installed after 1980. It can be observed that the failure rates in general are very low, which also is expected because the overall failure rate, cf. figure 4, is very low. There could be an indication of a rising failure rate for cables with service time approaching 30 years. However, because the observed rise in the failure rate is so low and because the rise is from one very low level to another low level it is difficult to conclude that a rise so far actually has been observed. A least such a conclusion should be drawn with caution. The higher failure rate after close to 30 years could also be due to the fact that some steam-cured cables could have been installed around 1980 and therefore be included in the failure rate. However, it will be interesting in the coming years to follow the development in the failure rate, when a larger share of the XLPE cable population reach service times of 30 years or more.

The failure rate on figure 7 is underestimated due to the fact that the installation years of the cables only are known for approximately 50% of ageing related failures since 1980. However, the real failure rate is not expected to be

significantly higher or have a significantly different shape: nothing in the general failure rate suggests that.

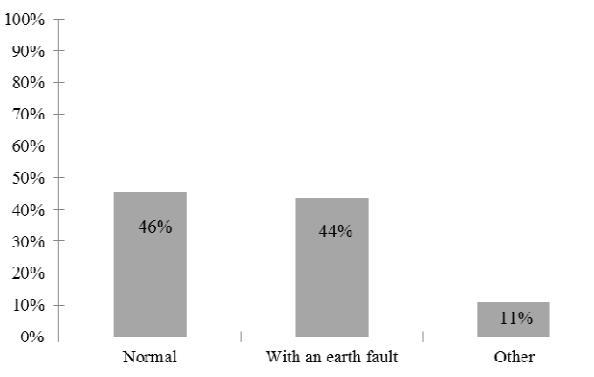
Figure 8: How the system was operated at the time of the failure.

On figure 8 is shown how the system was operated at the time of the failure. The figure is based on information from 709 failed cables. 'Other' covers failures initialized by switching operation, lighning events, testing, etc.

In Denmark MV system is either resonance earthed or operated with an isolated neutral, which means that the systems can be operated with an earth fault present, but with an elevated phase-to-earth voltage on sound phases. Close to half of all ageing related failures on XLPE cables happen while the system is operated with an earth fault, cf. figure 8. In the failure statistic there are also several examples where one earth fault has created a cascade of faults on XLPE cables due to the elevated phase-to-earth voltage on sound phases.

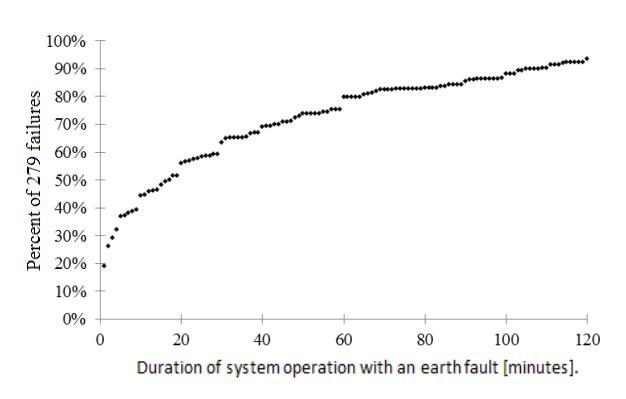
Figure 9: Duration of system operation with an earth fault before a second earth fault occurs on a XLPE cable.

In figure 9 it is shown how long time a system has been operated with an earth fault before a failure on a XLPE cable happened. The figure is based on 279 failures where this time interval is known. Close to 40% of them happen within 5 minutes after the first earth fault and 60% happen within 30 minutes. However, close to 30% of the failures happen within 60-120 minutes or more after the first earth fault. This could be interesting information in case of maintenance test where cables are stressed with an overvoltage during a preset time to provoke a fault at a weak point. Several recommendations for power frequency testing of cable systems exist, e.g. CENELEC [3] and IEC [4]. Both focus on after installation test. They generally agree on the test voltage, which is set to $2U_0$ in [3] and the phase-to-phase voltage [4], but differ on the recommended test durations, which are 15 minutes in [4] and 60 minutes in [3]. Compared to the experiences from the Danish failure statistic, cf. figure 9, these recommended test durations would potentially have been able to find approximately 50% [4] and 70% [3] of the 279 failures in figure 9.
