DIAGNOSTIC TESTING OF MEDIUM VOLTAGE CABLES BY PARTIAL DISCHARGE LOCATION RECENT FIELD EXPERIENCE

M S. Mashikian, C. Han and S. Ziegler
IMCORP™

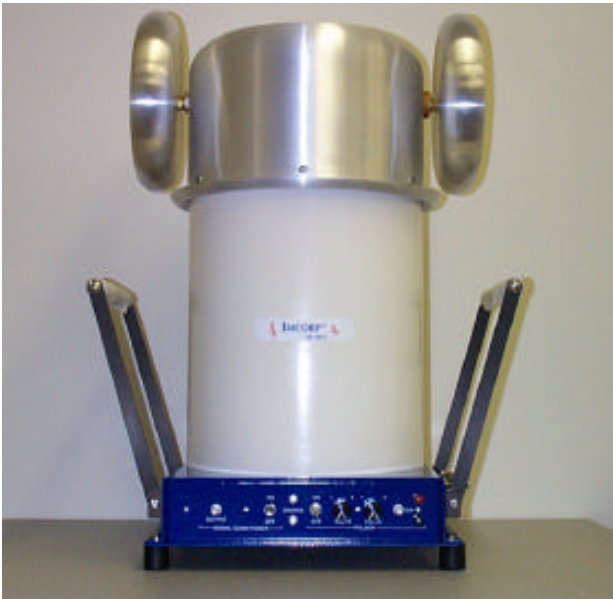
The signal conditioner, shown in Figure 1, consists essentially of a coupling capacitor, a high frequency blocking circuit, a passive (resistive-capacitive) high-pass filter, an amplifier, and protective and matching circuitry. It is placed as close as possible to the termination of the cable under test (test cable), and is connected to the high voltage excitation source by means of a flexible, PD free, high voltage cable

Figure 1. Photograph of a 75 kV Signal Conditioner.

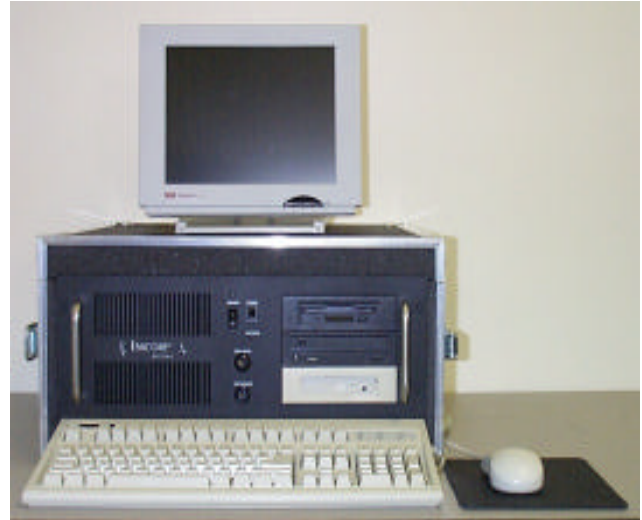
The estimator, shown in Figure 2, is the heart of the PD locating system. It comprises a fast digital data acquisition subsystem, a modern Pentium type processor with graphical user interface, matching input circuitry, two special bandpass filters providing external triggering capability, and a variety of data transfer ports.

Figure 2. Photograph of the Estimator

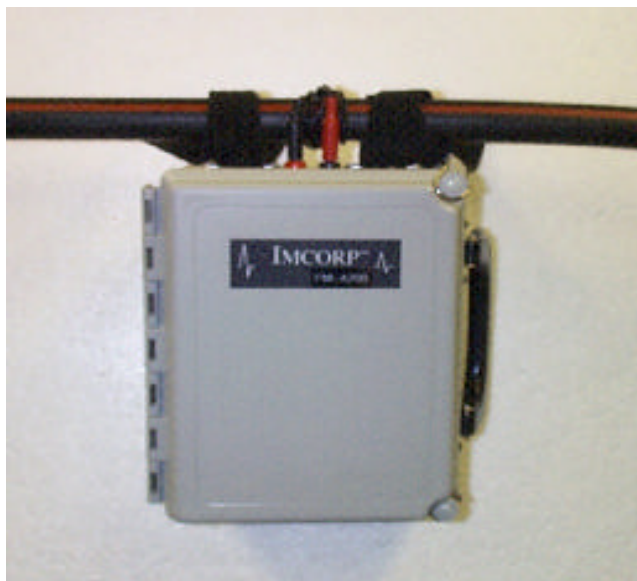
Two general models of matcher were developed. Model A, which is commercially produced, requires that a small test hole be dug in an estimated vicinity of the defect, until the cable is visible. A voltage pulse is applied across a coil

wound around the cable. This sets up in the cable a travelling wave similar to a PD signal. The estimator processes this signal and determines the location of the coil along the cable. This allows the field crew to move along the surface of the ground by an appropriate distance in order to dig a 2-3m long trench within which the PD site should lie. Figure 3 illustrates this matcher.

Figure 3. Photograph of Matcher Model A.

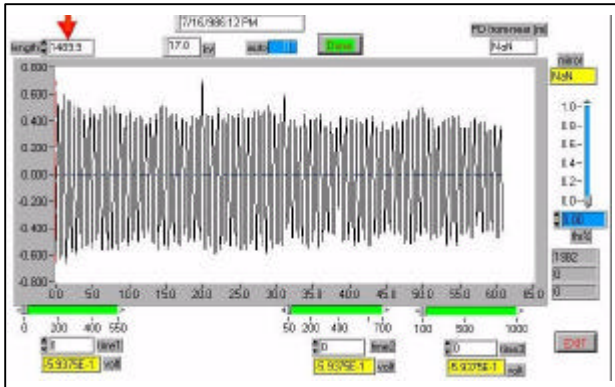
Ambient noise is sampled repeatedly and its frequency spectrum determined. The adaptive digital filters of the estimator are then set to eliminate the most offending frequencies, such as powerful neighborhood radio stations. The detection sensitivity can increase 5 to 10-fold when this feature is used. Figure 6 was a signal recorded in a field measurement when the digital filters were deliberately turned off. The PD pattern was almost totally masked by noise. Figure 7 represents the same signal, when the filters were activated. The difference is very clear.

Figure 6. Reflectogram of a PD with filters turned off.

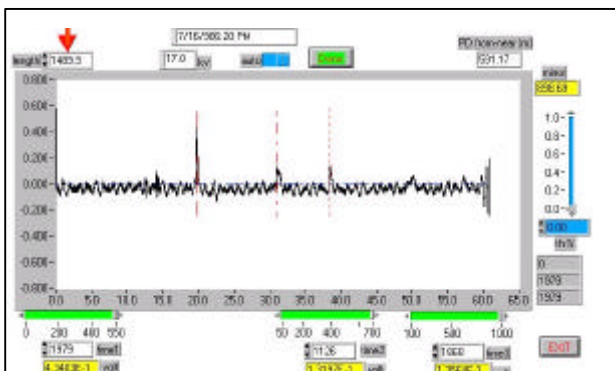
Figure 7. Reflectogram of Figure 6 with filters turned on.

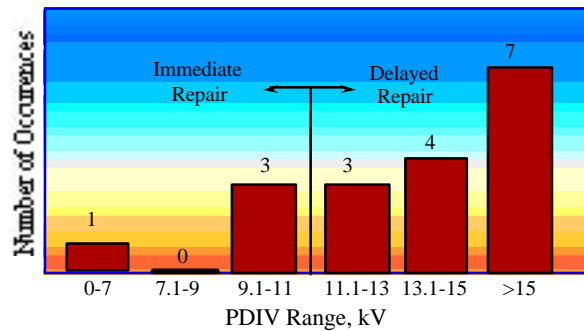
A histogram of the defective joints, sorted by PDIV range, is shown in Figure 8. Assuming that all joints with PDIV 11.0 kV will fail within one year, a total of 5 joint failures per 100 km per year are predicted. Similarly, on the basis of one defective cable, a total of 1.25 cable failures per 100 km per year are predicted. The actual failure rates compiled by the utility were 1.11 and 3.81 for cables and accessories, respectively. PD testing, although performed on a relatively small sample size (80 km), predicted failure rates within comparable ranges.

Figure 8. Case 2: Histogram of defective joints.

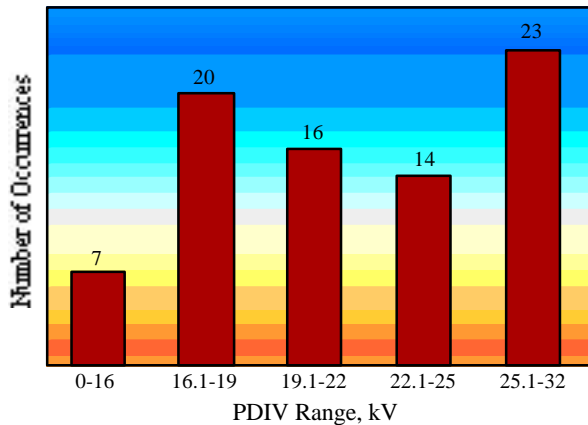
method while assessing the condition of joints with a history of repeated failures in the 27.6 kV, XLPE cable system. The test voltage for this system was limited to $2U_0$. A limited number of 13.8 kV cable sections were also tested with maximum voltage levels ranging between 1.5 and $3.0U_0$, the wide variation being imposed by the utility for operating reasons. The test results are listed in Table 2, and a histogram of the test results on the 27.6 kV joints is shown in Figure 9.

Figure 9. Case 3: Histogram of defective 27.6 kV joints.

The relatively low incidence of cable defects is compatible with the failure rates expected for such systems. The tests identified several severely defective 27.6 kV joints, namely those with a PDIV equal to or less than the 16 kV service voltage. This confirmed the reason for the high failure rate.
