A PRACTICAL APPROACH TOWARDS ESTIMATING REMAINING MV CABLE LIFE

Johannes G. (Han) SLOOTWEG
Essent Netwerk B.V. - Netherlands
han.slootweg@essent.nl

E. Fred STEENNIS
KEMA Nederland B.V. - Netherlands
fred.steenis@kema.com

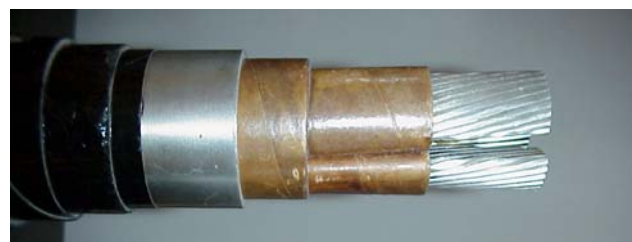
Figure 1. Three core PILC cable with aluminium conductor

Either copper or aluminium can be used for the conductors of both PILC and XLPE cable. For 10 kV, the most important voltage level for MV networks in the Netherlands, PILC cables tend to be three core belted cables. Older PILC cables sometimes have very small cross sections, such as 10 mm² and 16 mm². XLPE cables with a relatively small conductor cross-section (i.e. up to about 200 mm² to 250 mm²) exist both as single core and as three core cables. Larger cross-sections are only manufactured as single core, because as three core they would become too heavy and difficult to handle and to bend.

In figures 1 and 2, the cross sections of a PILC and an XLPE cable are depicted respectively. Several layers can be distinguished, such as the conductor, the insulation, the earth sheath, and several sealing and protective layers.

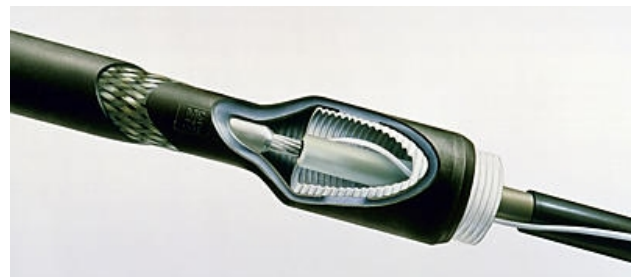
Figure 4. Example of cold shrink joint (source: 3M)

There are two main types of straight joints, namely filled joints and massive joints (see also figures 3 and 4). In filled joints, some type of insulating material (such as oil, silicon gel, resin or bitumen) is used to insulate the casing from the cable conductors and (in three conductor cables) the conductors mutually. In massive joints, the insulating material being used is solid from the outset. Processing of massive joints can be done through heat or cold shrinking or pre-moulded joints can be used. Some manufactures combine both principles, e.g. a shrink approach to connect the conductors of both cables, after which the joint is filled with some type of viscous material. Wrapping joints also form a combination of filled and massive joints: first, a

The most important ageing mechanisms of massive joints, either heat shrink, cold shrink or pre-moulded, are caused by contamination of the joint before it is installed and voids between the conductors and the joint. Both are mainly caused by bad installation circumstances and inaccuracies,

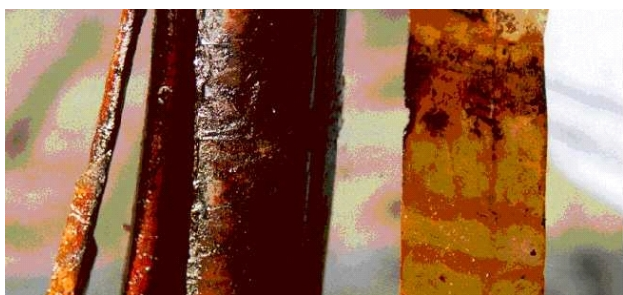
Figure 5. Example of aged paper insulation

In principle, all parts, or layers, of a cable have a finite life time and are subject to ageing. The ageing mechanisms, however, differ. The oil impregnated paper used as insulation material in PILC cables can age due to high temperatures, which can be caused by (a combination of) high current loads and/or a “bad” thermal environment, e.g. bad soil properties or other heat sources such as other cables nearby or district heating. This leads to the drying of the oil and de-polymerization of the paper, see also figure 5. This can result in electrical treeing and breakdown. The latter can also be caused by moisture ingress occurring after a breakdown of the cable or due to a corroded lead sheath. Finally, the armour can be corroded, which severely reduces mechanical strength of the cable. However, as long as the cable is not moved or touched with excavation works, this does not cause any problems.

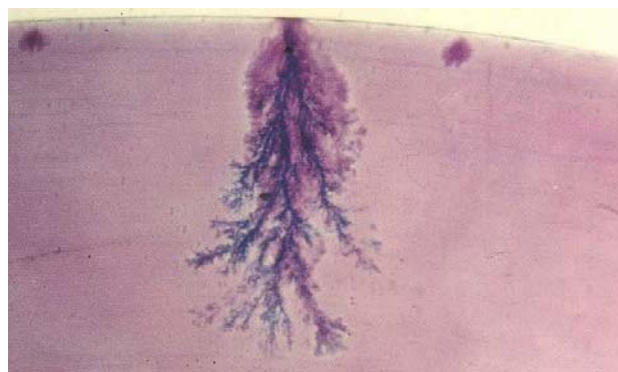
Figure 6. Example of “vented” water tree in XLPE

Further, XLPE insulation can be affected by what is called “water-treeing” [1]. A water tree is a diffuse structure in a polymer with an appearance resembling a bush or a fan. They result from the degradation of polyethylene by means of a combined action of water and an electric stress. Water trees reduce the electric breakdown stress level of a polyethylene insulating material. Water trees can be made visible by several dyes, see figure 6 for an example.
