## ADVANCES IN THE DECOMMISSIONING OF END-OF-LIFE OIL FILLED CABLES

*The oil removal process developed by EA Technology is now available as a service to network owners and contractors. The process delivers the major benefit of rendering end-of-life oil filled cables in a condition where they no longer pose a significant long-term threat to the environment. This paper describes the procedures taken to ensure a successful operation. It then goes on to consider the results of a successful oil removal from an undulating 1.5 km, 33 kV circuit.*

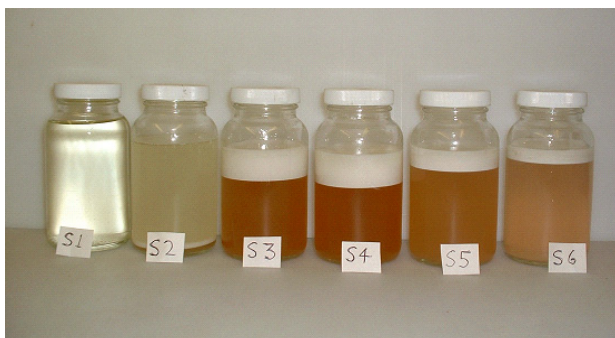
Figure 4: Effluent samples taken on Day 2

Figures 4 to 6 show the 17 samples of effluent taken on Days 2 to 4. Note that sample S1 is pure oil. Sample S2 was 91% oil, with the small aqueous layer just visible at the bottom of the jar.

The dye was observed in the effluent stream shortly after the taking of sample 14. At this point about 580 litres of fluid had come out of the cable following the start of the dyed water injection. This is slightly less than the estimated readily accessible free volume in the system (ducts and joints) of 670 litres. To a large degree the water being pumped into the cable pushes the column of water in front of it with relatively little axial mixing. However, it is not quite as simple as that, because at the end of the process dye was still observed in the effluent (although the colour was much less intense), and this was after the second dye-free water batch had been pumped in. We deduced that some of the dyed water had infiltrated recesses of the cable away from the ducts and is only slowly leached out by the clean water. This is, of course, what is required. Not only must the water (or detergent) push out oil in the ducts; it must also penetrate and wet the more inaccessible parts of the cable.

It can also be observed that the aqueous phase was initially very dark at the start of each day, but became lighter as the process progressed. This is almost certainly because of the known leak on the system. The gas from the purge on Day 1 probably leaked away quickly. When the pressure was equalised between the outside environment and the cable, dirty soil water would have been admitted overnight at the leak position. Internal cable pressure is more easily retained with liquid in the system, so that, during the subsequent injection of detergent, flow of soil water into the cable system at the leak point is less likely. Hence, with the replacement of the soiled water by fresh, there is a gradual reduction in colour intensity.
