PARTIAL DISCHARGE MEASUREMENT SYSTEM AND FAULT ANALYSIS OF 25.8KV SF₆ GAS INSULATED SWITCHGEAR IN KOREA

ABSTRACT

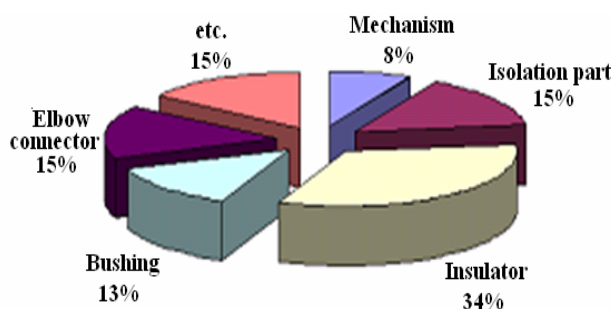
Fig. 1 shows the perception of a survey on the causes of GIS breakdown

Fig. 1 Faults perception

- mis-operation : grease hardening , corrosion of switchgear, broken shaft
- insulating materials : contact badness of electrodes, transient over voltage, tracking phenomena of the polymeric insulation material.
- damage of bushing : defect in voltage screen
- breakdown of elbow connector : surface damage, loose contact of connector
- others : moisture absorption, trouble of control circuits

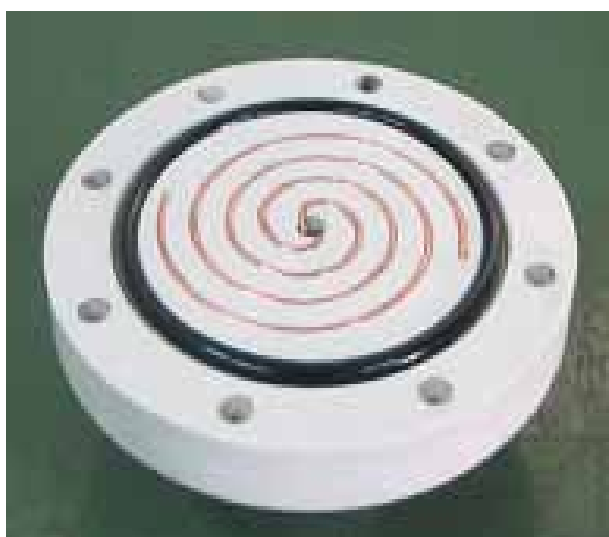
The internal UHF PD sensor, which detects PD signal inside of GIS, was designed by using the principle of broadband frequency characteristic of Archimedean spiral antenna[2-3].

Fig. 3 Internal UHF sensor(proto-type)

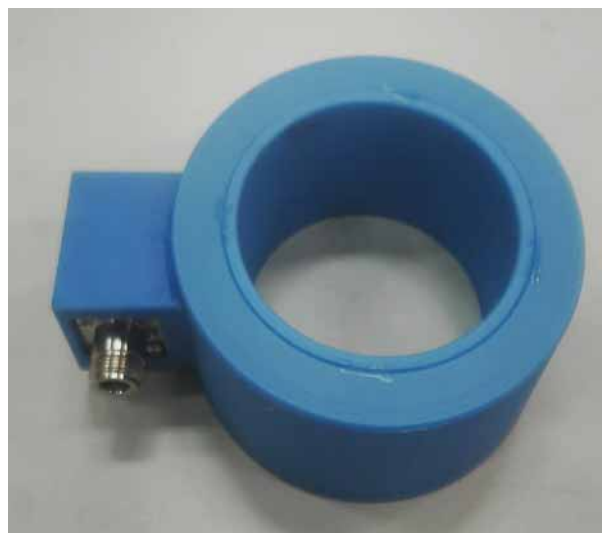
The external UHF PD sensor, which is set up outside of GIS and detects PD signal of inside GIS, was designed by using the principle of narrow band frequency characteristic of log-periodic antenna.

The sensor can be installed at GIS bushing while the GIS operate. And it has a shield structure to minimize outside noise.

Fig. 4 External UHF PD sensor(proto-type)

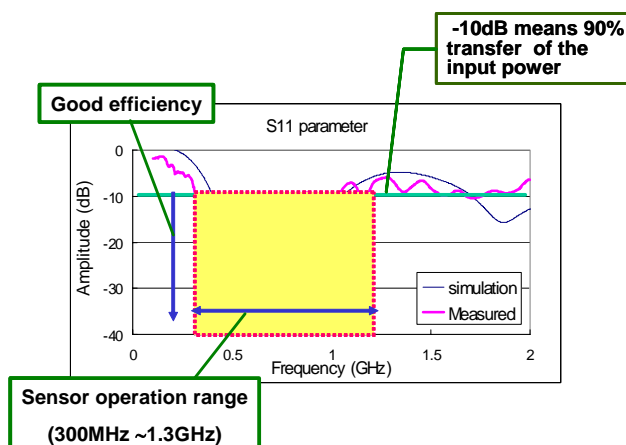
Fig. 5 The comparison of results between test and simulation

To get the performance of internal UHF sensor, we measured S_{11} parameters. A network analyzer was used to testify the internal UHF sensor in free space, work place, and GIS. Fig. 5 illustrates the comparison between simulation results and tests, and it shows difference result. The reason of the difference result is out of accord with the condition of test. The result shows that the sensor has excellent value under 10dB in 300[MHz] ~ 1300[MHz] band.

To compare total band of frequency, internal sensor has 5~10[dB] of characteristic transmission value that is higher than the external sensor. However, sensibility of the external sensor was highly performed at its resonance frequency area, which is between 300[MHz] and 1,200[MHz].

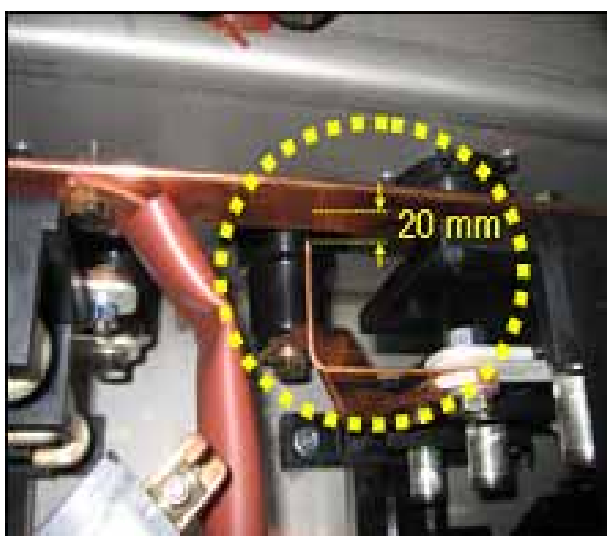
Protrusion was made by using 2[mm] copper wires, cutting its edge sharp, and was put into the third circuit of B Company’s switch as shown in Fig. 6. To simulate under severe conditions, the experiment was carried out within a 15[mm] gap between ground stirrup and power unit.

Fig. 6 Protrusion

While the several tens of PD signals were generally not damaging the system, however if the transient voltage occurs to the system, they can cause misoperation or faults. The PD signal was found in both the internal sensor and external sensor between the 900 ~ 1200[MHz] bandwidth.

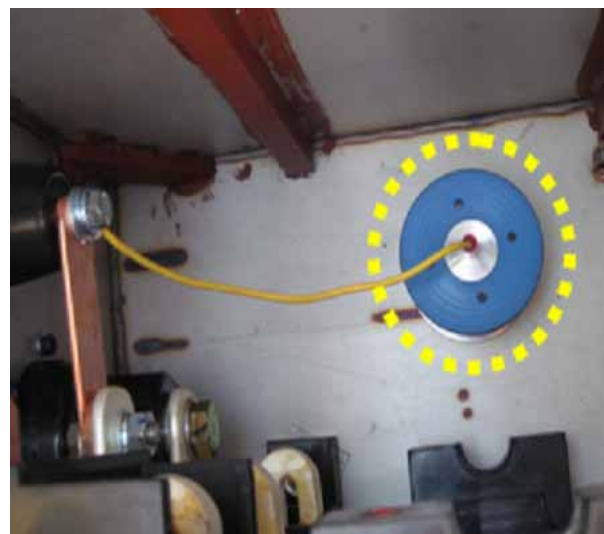
To make shortage of the free moving particle, which was made as an electrode type, the free moving particle was installed into the first circuit of “A” company’s switch, as shown in Fig. 7.

The space between upside and downside electrode was controlled to 12.5[mm] in diameters while the ball type aluminum to produce PD signal was 1[mm] in diameter.

Fig. 7 Free moving particle

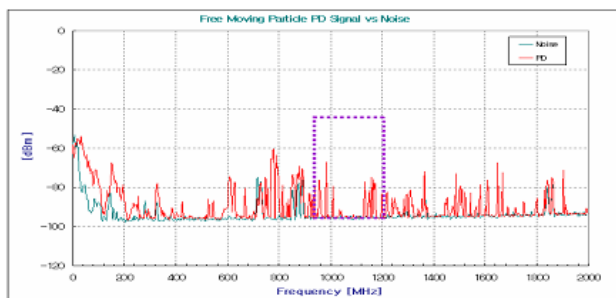
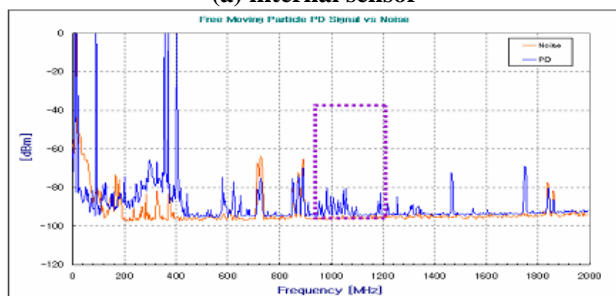
The PD signal was found in nearly all frequency bandwidth with the PD signal at about 5[pc]. And it was found in both the internal sensor and the external sensor with the main target area of 900~1200[MHz]. This type of the defect classifies serious damage on the system. It may not happen by the aging phenomena, but by mechanism. Fig. 9 shows the signal of PD on free moving particle.

(a) internal sensor

(b) external sensor

Fig. 9 The signal of PD on free moving particle
