## LONG TERM BEHAVIOUR OF OUTDOOR TERMINATIONS MADE OF SiR

### ABSTRACT

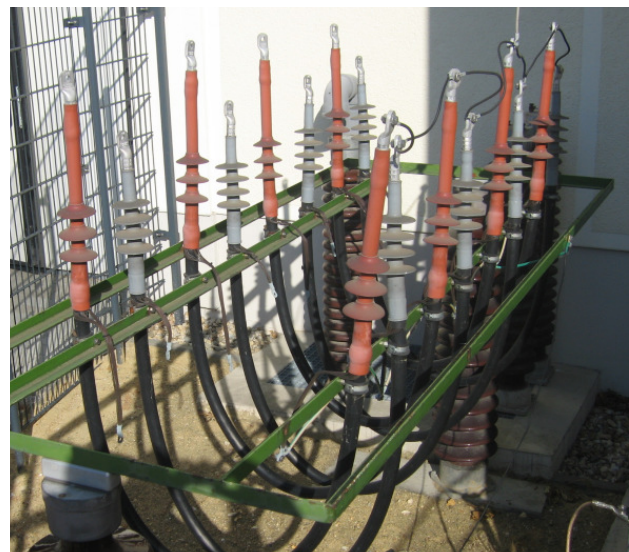
The terminations of the type CAE-F 12/20(24) were mounted on both end of an 20 kV cable of the type NA2XS2Y 150RM/25 with a length of approximately 3 m in April 2004. **Fig. 1** shows the test setup after installation. Only 2 cables with 4 grey terminations were selected for this investigation. The other terminations were not used for this investigation.

**Fig. 1:** Installed test objects.

The terminations were mounted at the outdoor test field of the University of Applied Science Zittau/Görlitz. The climate during the tests was typical for Middle Europe with temperatures from -25°C...35°C consisting of dry and humid periods – e.g. fog, rain, snow and ice. The contamination range was from light to medium.

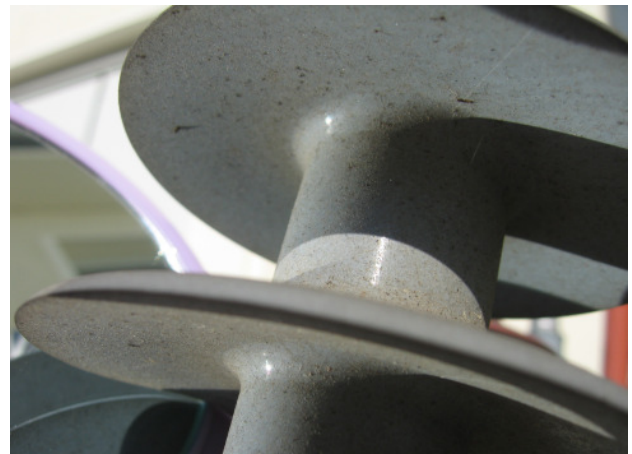
**Fig. 3** shows the surface of one termination representative for the test samples.

**Fig. 3:** detailed view of a termination after the long term electric stress.

Surface contaminations were visible but no damage on the silicone surface of the terminations could be noticed. There were neither creepage tracks nor erosion tracks on the surface of the termination visible.

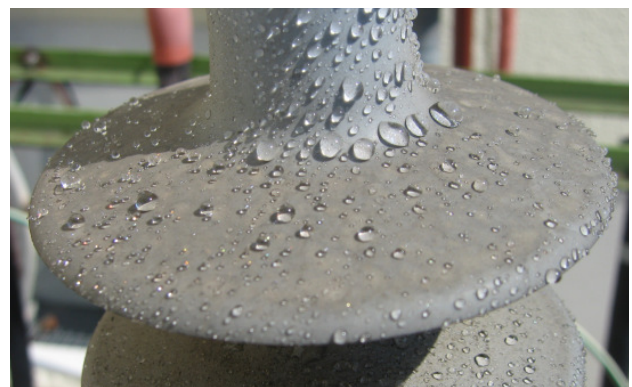
**Fig. 4** shows a termination sprayed with water droplets to determine the hydrophobic class of the termination along the surface.

**Fig. 4:** Termination sprayed with water droplets.

The hydrophobicity was good to excellent across the whole surface of the terminations. The long term stability of the surface was proven and also the transfer of the hydrophobicity through the surface contamination was given during the whole test period of 5,5 years. The hydrophobic class was measured along the whole surface of the termination. **Fig. 5** shows the measuring points in detail.

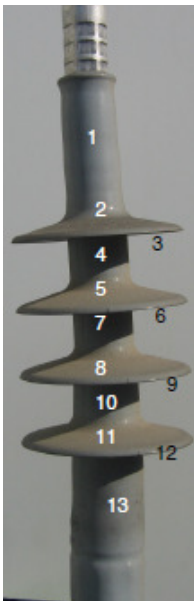
**Fig 5:** Measuring points of the hydrophobic class spread along the surface of the termination.

The hydrophobic class on the shed was from HC 1 to HC 2. Most of the parts of the trunk had also HC1 to HC 2 except a few portions showing HC 3-4.

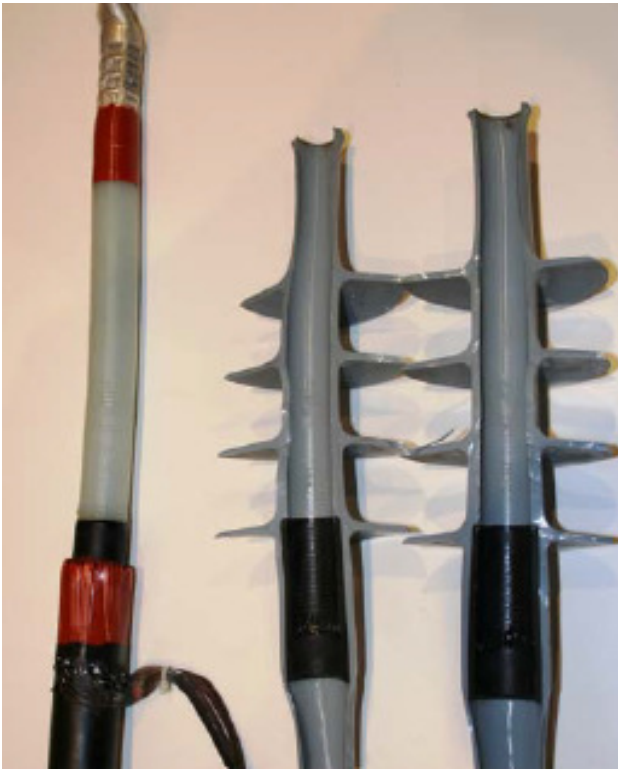
After all these tests the terminations were cut and dismantled from the cable. **Figs 6** and **7** show the overall view and a detailed view of the dismantled termination and the VPE cable resp.

**Fig. 6:** Overall view of the dismantled termination and the VPE cable.

During this visual check no discharge traces could be found on the VPE cable and on the inner SiR-surface of the termination. The interface VPE-cable – SiR-termination was practically in new condition after all the conducted tests.
