## THE EFFECT OF HIGH CURRENT LOADS ON JOINTS IN MV CABLE SYSTEMS

### ABSTRACT

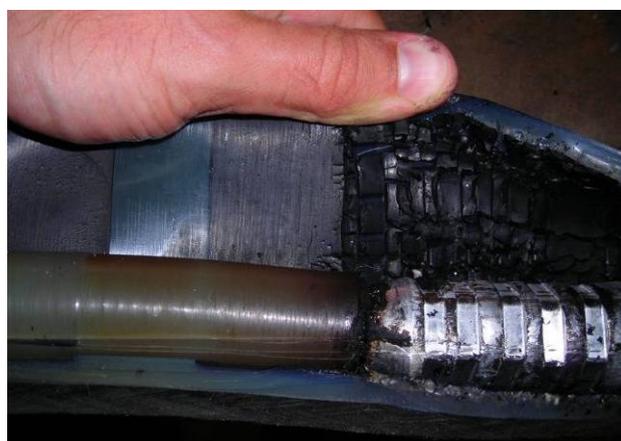
Figure 3 Conductor connector that came loose and thus started to heat its surrounding joint material.

For instance, a high cycling current will give large extension and contraction forces on the conductor connector and certainly if the connector is not fully suitable for the cable conductor, the connector will come loose from the conductor. At these high currents and high interface resistance there will be a lot of heat produced, resulting in voids in the surrounding insulation and on its turn this will give high electrical fields in the gas filled voids which already are a weaker insulation material compared to a solid insulation. In the end, the joint will fail. An example of such a conductor connector applied in an XLPE cable joint that caused the degradation of the surrounding joint material is shown in Figure 3. Of course one can claim that we are dealing here with a wrong connector or with a wrong installation. True. But in practice this is a real risk and in the end, the ageing comes with the high current load.

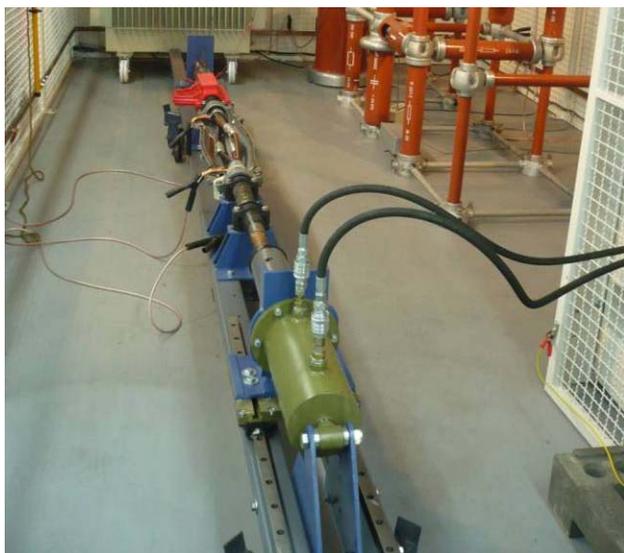
Figure 7 Test set-up where the mechanical forces applied to the conductor can be created by oil pressure.

The first experiments in the laboratory were made to check whether it was possible to simulate the "real-life" phenomena as experienced by network owners in many of their failed joints. For that purpose a test set-up was made (shown in Figure 7) where the joint was connected to short cable sections only. On one side the cable is blocked. On the other side a hydraulic cylinder could realize the calculated pressure on the cable conductor and in this way the effect of the mechanical force (up to 50 kN maximum) could be made visible.

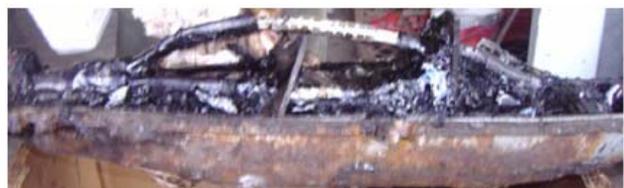
Figure 9 Field result: a similar joint as shown in Figure 8, but failed in service due to conductor extension.

For instance, what could be made visible in this test set-up is the conductor extension where the conductor bends itself sideward, as is illustrated in Figure 8 and Figure 10. Compare this result with a failure as seen in service as shown in Figure 4, Figure 9 and Figure 11.

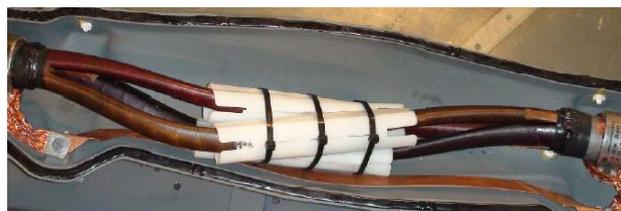
Figure 10 Conductor extension when the force is about 6 kN. The potential degradation of the paper insulation is very likely in case of a cyclic load.
