WOOD POLES NON-DESTRUCTIVE INSPECTIONS; THE GERMAN EXAMPLE

Yann BENOIT
CBT SA – Switzerland
benoit@cbs-cbt.com

Jean-Luc SANDOZ
CBS - France
sandoz@cbs-cbt.com

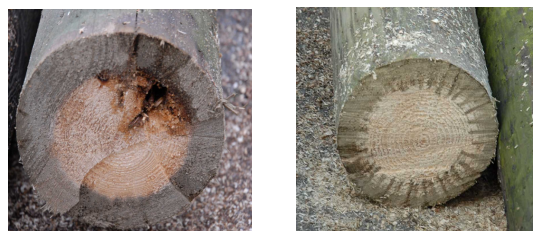
Figure 3: Comparison between the Polux measurement, the decay presence and micro-drilling method. Decayed pole on the left, sane pole on the right.

From the 750 inspected poles, a sampling has been removed from the field to be visually inspected: the poles were cut at ground line to observe any presence of decay under the ground line level (Figure 3).

The measurements were then compared to a micro-drilling method previously used by Deutsche Telekom.

The advantage of Polux is the numbered result: no interpretation is required, what is not the case for another method.

All the strongly decayed poles have been rejected by Polux, and many unjustified rejected poles by micro-drilling could have been saved by Polux.

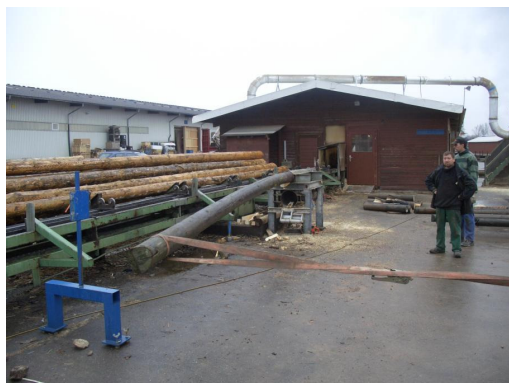
Figure 4: Destructive tests and comparison with Polux residual strength evaluation. Tests in Hüfingen, Germany, Fürstenberg Holz.

Those tests were performed at a wood pole supplier: Fürstenberg Holz in southern Germany (Hüfingen). Figures 4 and 5 illustrate the tests and the results respectively.

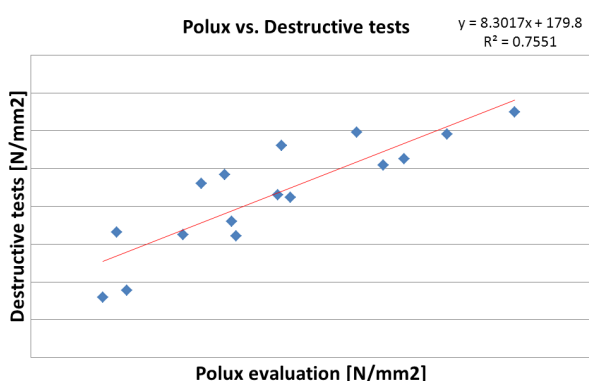
Figure 5: Destructive tests results vs. Polux evaluation. $r^2=0.76$, $n=16$ poles.

The correlation between Polux evaluation and the destructive tests presents a coefficient of determination $r^2=0.76$, a result similar to the other correlations in other countries and/or other species.

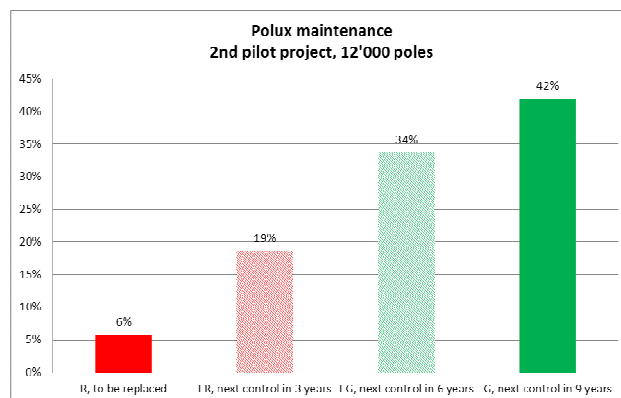
Figure 6: Polux maintenance results (including complementary visual inspection). 12'000 poles, 2nd pilot project for Deutsche Telekom. Salts and creosote poles mixed.

The maintenance results for the 2nd pilot project combining both Polux and visual inspection are given by the figure 6 and summarized as follow:

- Poles to be replaced: 6%
- Next inspection in 3 years: 18%
- Next inspection in 6 years: 34%
- Next inspection in 9 years: 42%

The Polux results reduce strongly the number of poles to be replaced (6% with Polux vs. 16% before) and extend the inspection cycle for the best ones. This has strong economic advantages.
