## EXPERIENCE PERFORMING INFRARED THERMOGRAPHY IN THE MAINTENANCE OF A DISTRIBUTION UTILITY

José MARTÍNEZ  
Edenor S.A. – Argentina  
jmartinez@edenor.com

### ABSTRACT

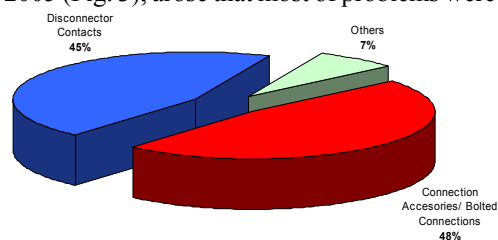
Fig. 3 - Distribution of thermal abnormalities by component Period 1999-2005.

From the results of IR scans performed during the period 1999-2005 (Fig. 3), arose that most of problems were found

in conductor connection accessories and bolted connections (48%), mainly derived from deficiency of adjustment and/or materials (anomalies in bimetallic surfaces joints, rust, non adequate use of inhibitory grease).

Besides, an important number of thermal anomalies appears in disconnectors contacts (45%), from mainly of defected contacts by deformations, deficient pressure of contact, incorrect alignment of arms and dirtiness (Fig. 4).

These determinations allowed to focus the tasks developed during the scheduled PM, introducing improvements in the maintenance practices carried out. Besides that, an increased awareness by the maintenance working teams in the actions executed to solve the abnormalities detected was achieved, resulting this in an important contribution for the decrease of the critical “hot spots” found.

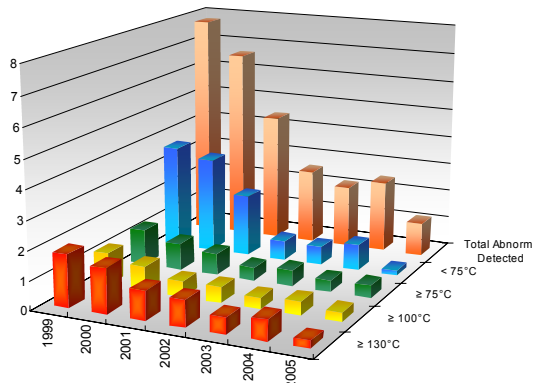
Fig. 5 - Evolution of thermal abnormalities by critical levels Period 1999 - 2005 (in per thousand of items scanned).

By analyzing the evolution of the abnormalities detected during the period 1999-2005, we see that in the period as a whole, a growing tendency to the reduction of thermal abnormalities related with the total number of item scanned for all critical levels is presented (Fig. 5).

The decrease of thermal abnormalities with higher critical level is attributed to its early detection and their addressing by means of programmed outages, taking corrective actions to prevent the abnormality could evolve to a worse critical level. On the other hand, the decrease of thermal abnormalities with a lower critical level can be attributed to an improvement in the practices of the maintenance working teams since the experience acquired.
