STUDY AND INVESTIGATION OF MEDIUM VOLTAGE POLLUTED INSULATORS IN ALEXANDRIA DISTRIBUTION GRID

Prof. Ahmed HOSSAM-ELDIN
Electrical Eng. Dept. , Alexandria Univ. - Egypt
a.hossamudn@gmail.com

Ibrahim MADI Sami SHARAF
Alexandria Electricity Distribution Company - Egypt

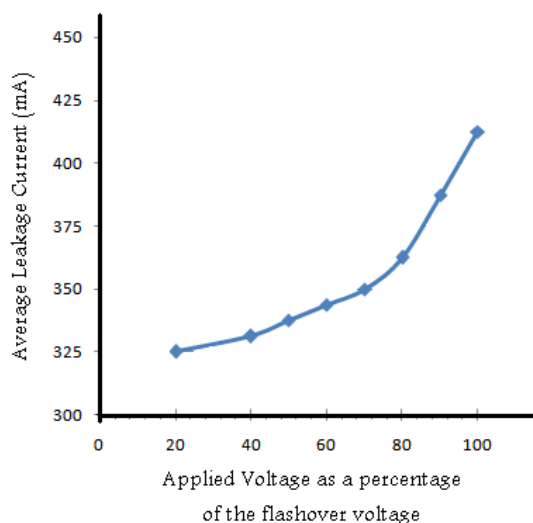
Fig.4 Leakage Current Measurements

It can be observed that flashover usually occurred when the leakage current reaches 300 to 450 mA.

iii) It is clear that the leakage current increase by increasing the flashover voltage as shown in fig (4).

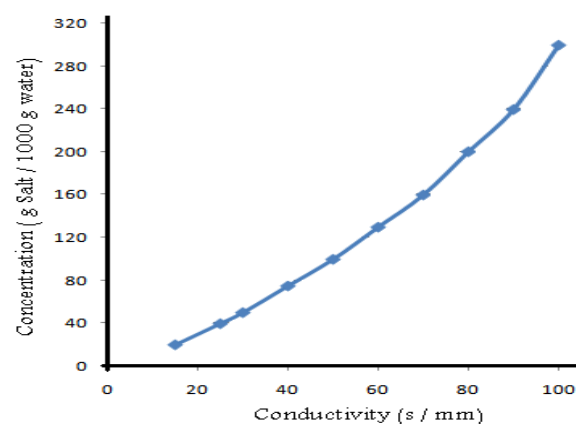
Fig.5 Conductivity Measurements

The pollution increases the conductivity on the insulator surface This may be attributed to the increase in the contaminations permittivity and loss tangent which adds to the dryness of the leakage path which advances the strike of arcs.

(iv) The results showed an increase in conductivity according to the salt concentration in the contaminant and vice versa. This may be attributed to the mobility of main charge carriers compared to the mobility of minor carriers. It has been noted that the conductivity of the deposited pollution depends on the type of salt in this location and the thickness of the deposited layer. It also depends on the shape and dimensions of the insulator (leakage path) fig (5).
