CONDITION BASED RISK ASSESSMENT OF ELECTRICITY TOWERS USING HIGH RESOLUTION IMAGES FROM A HELICOPTER

Graham Earp

EA Technology – United Kingdom

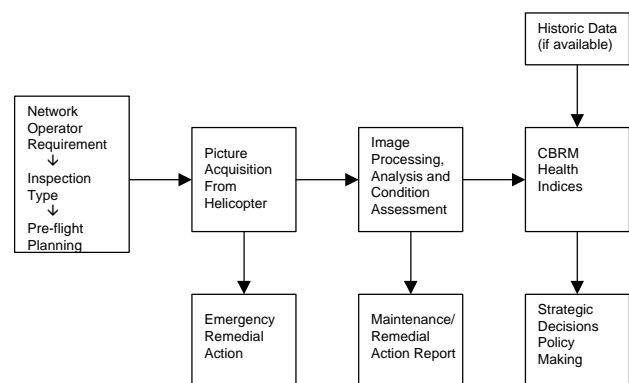
Figure 1. Overview Of Tower Inspection Methodology

Figure 1 gives an overview of the method sequence in block diagram form. A brief overview of each of the functions is given in the following sections.

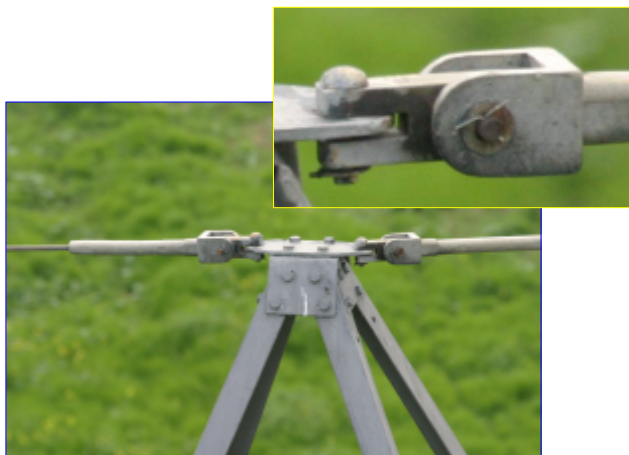
Figure 2. Use Of Digital Zooming To Examine Detail

The picture acquisition system employs a high resolution digital still camera. This is fitted with a high magnification telephoto lens that incorporates optical inertial stabilisation to reduce blur induced by helicopter motion and camera shake. Image resolution is typically greater than 3000x 2000 pixels which means that they will support digital image zooming on a PC during analysis to reveal greater detail on screen without pixelation as shown in Figure 2.

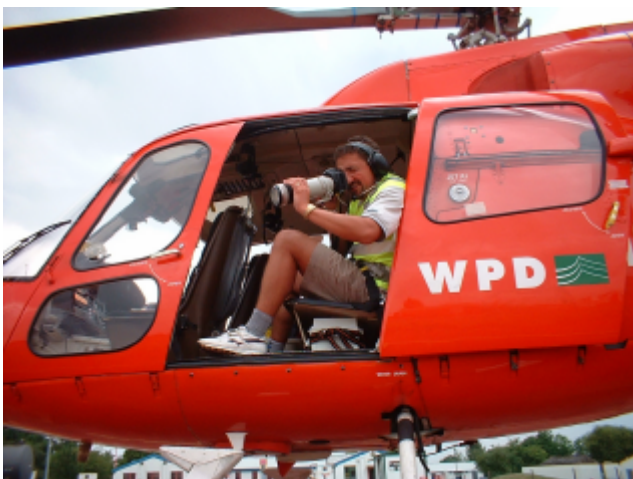
Figure 3. Camera Deployment

Once the helicopter arrives on station, the camera is deployed through the open door by an operator wearing a safety harness (Figure 3). This gives the greatest flexibility to capture the images of key tower features as determined by the inspection type and requirements. This is an important feature of the technique, as it effectively produces a significant degree of data reduction at the front-end of the process by only capturing information that is crucial to the requirements of the inspection. In contrast, video recording techniques can result in hours of unwanted footage that has to be filtered out afterwards. This is a time-consuming and laborious task.

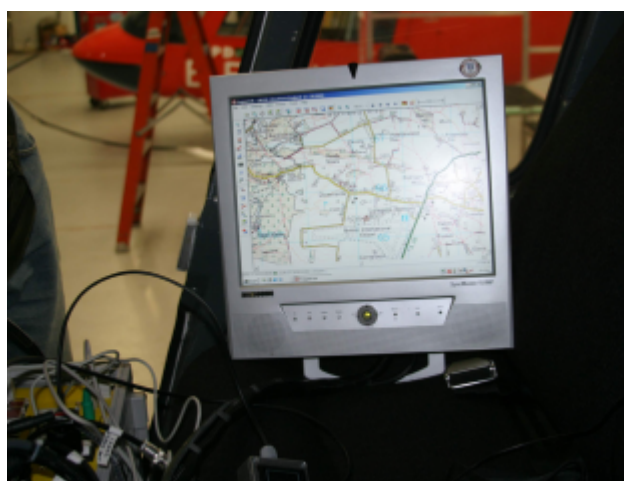
Figure 5. GPS-driven Moving Map Display To Aid Asset Identification

In addition to providing a GPS-driven moving map display to aid tower location and positive identification from the air (Figure 5), it will also automatically record various time, date and positional (National Grid Map Reference) information for each photograph taken. It is totally self contained and independent of the helicopter systems so that it can be quickly fitted to almost any helicopter. It can also be deployed at the same time as a conventional visual or thermal inspections, and can be used to capture images of specific defects, wood poles, substations, tree encroachment, and land use if required, as well as tower images. The system has the capacity to store many thousands of images during a single inspection sortie, which will typically be of 2 – 3 hours duration including positioning. Flying speed is heavily dependant upon the level of detail (i.e. number of images) required per tower. For a simple inspection requiring say three images per tower, speeds of up to 40 knots can be achieved. Highly detailed inspections requiring say 20 images of each side of each tower will reduce the speed significantly, but will still be much faster than conventional climbing methods.

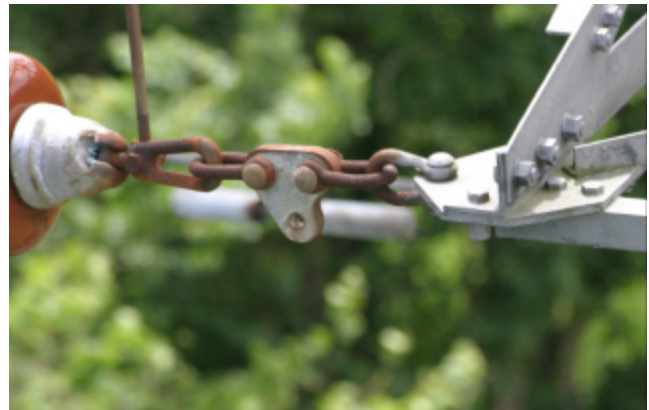
Figure 6. Typical High Resolution Inspection Image
