## ASSET MANAGEMENT IMPROVEMENT IN DISTRIBUTION STATION

### ABSTRACT

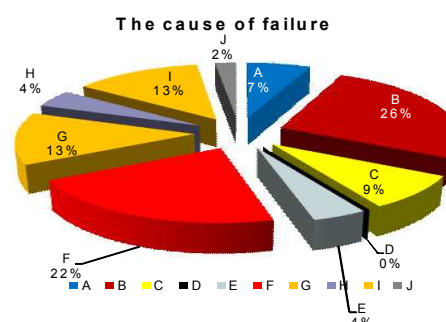
## Legend:

A	: Short Circuit of MV-LV	B	: Short circuit MV-Body
C	: Short Circuit of LV-Body	D	: Short circuit MV-LV-Body
E	: Winding Ins. Breakdown	F	: Oil leaks
G	: Breakdown of Accessories (Bushing, etc)	H	: Overheat (Body blown up, etc)
I	: Protection failure	J	: Others

The rate of distribution transformers failure at PLN Gambir tends to increase since 2007. The number of transformer failure in 2009 is 71, increasing 9,2 % from 2008. This number is equals to 2,8 % to the total asset owned. But in 2010, the trend decline due to the improvemnet in transformer treatment and proper maintainance. In 2010 the failure is 46 unit. In addition to causing damage to the transformer, the transformer failure also causes the increase of energy not serve (ENS) and transformer replacement costs each year. Majority of the fault were caused by short circuit between body and Medium Voltage side (21 %). The second bigger cause was due to the protection failure (14 %) and 12 % of the cause was due to leakage leading to oil drain. Further inestagation to each of failure led to the problem of excessive loading of distribution transformer and inadequate maintenance activities on distribution substations and transformers. To that end, numbers of efforts have been taken in order to reduce the number of distribution transformer faults with the implementation of asset management in operations and maintenance activities

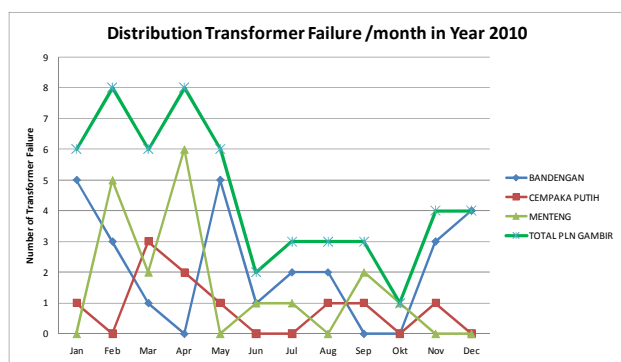
Figure 2 Distribution Transformer Failure

In figure 3 are shown in the graph disturbance distribution transformers per month in the Year 2010, which occurred in the PLN Gambir. The number of distribution transformers disorders seen showing a downward trend. This downward trend indicates an early indication of the improvement in the asset management of distribution transformers.

Implementation of the above programs have been undertaken and resulted in decreasing numbers of transformer failure in PLN Gambir as shown in Figure 3 below.
