MANAGING TRANSIENT INTERRUPTIONS ON AGED 22KV OVERHEAD LINES IN TNB DISTRIBUTION NETWORK THROUGH ENGINEERING PRACTICES ASSESSMENT AND INSULATION COORDINATION GUIDELINES

ABSTRACT

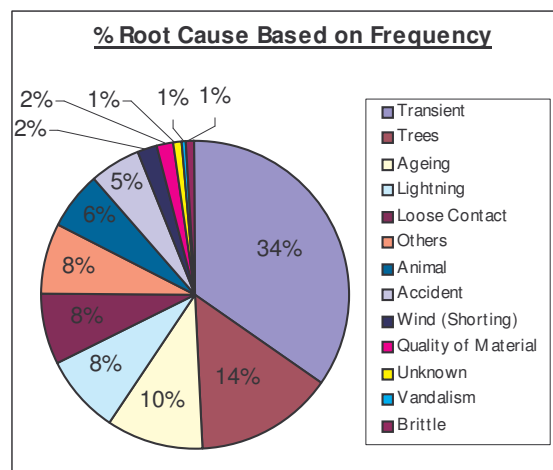
Graph 01: Typical Overhead Line Failure Causes

From Graph 01 above, it shows that transient is the leading cause for distribution overhead line interruptions in TNB

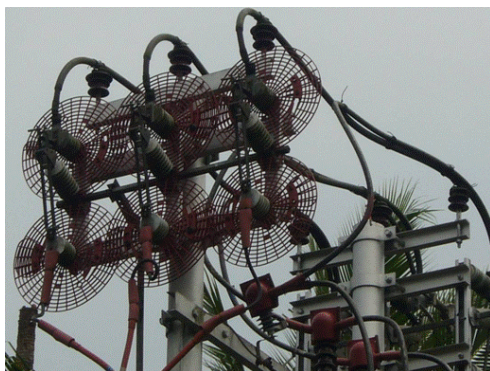
Photo 01: An Example of H-Pole Dressing

One of the challenges faced with overhead lines running through jungle areas or plantations is animal encroachment that can include rodent, monkeys, birds, and snakes. "H-Pole Dressing" can be employed to reduce breakdown and transient interruption caused by animal encroachment. A typical h-pole dressing currently employed in TNB is as shown in Photo 01 below:

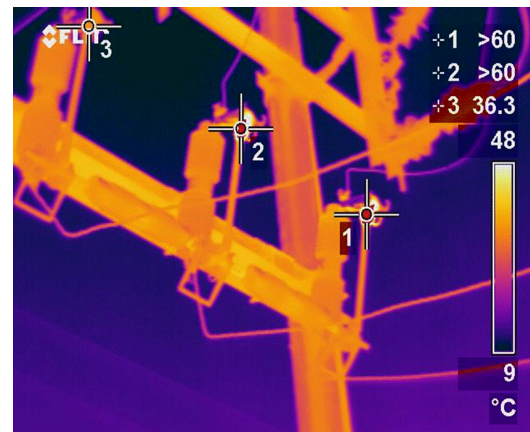
Photo 02: Hot-Spot Detection on EDO Fuse Assembly

Hot-spot, culminating from poor contact, is also a threat that can be considered for contributing to the high incidences of transient interruption especially on expulsion-type drop out fuse. When a drop-out fuse is exposed to hot-spot, the fuse rating tends to be de-rated. For example, a 10-A fuse can be de-rated to 2A when exposed to hot-spot. Because of this, whenever load picks-up during the day, this de-rated fuse tend to trip. Such incidence is also considered as transient interruption since whenever the fuse is replaced, no actual tripping occurs. An example of hot-spot detection of a drop-out fuse assembly is as shown in Photo 02 below:

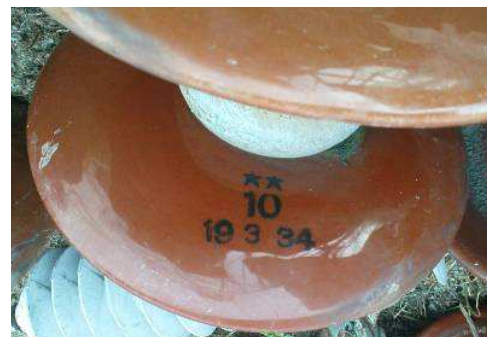
Photo 03: Use of Porcelain Insulators from 1934

Ageing component replacement is replacing those components that have exceeded their service life but are still installed in the system. These components are still in service due to the fact that they do not show any deterioration through visual inspection. However, components like porcelain insulators may have lost their dielectric strength but cannot be detected through visual inspection as porcelain insulators are known to have good mechanical strength. Thus, all ageing components that are more than 25 years are replaced regardless of the condition. As shown in Photo 03 below, some porcelain insulators manufactured in 1934 that were still installed in the system:
