EXPERIENCE WITH OFFLINE PD-DIAGNOSIS ON MV CABLES – KNOWLEDGE RULES FOR ASSET DECISIONS

Frank Petzold; Michael Beigert
SEBAKMT GmbH – Germany
petzold.f@sebakmt.com

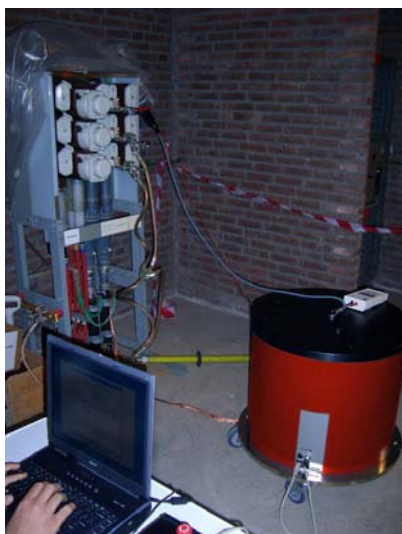
The experience of 6 years OWTS field application leads to some improvements in the new generation of the OWTS M-versions.

Besides the hardware optimization for light weight and small size, a new technology for automatically adjustment of the bandwidth of the measurement circuit for optimised signal detection and pd fault location was developed. That means in case of short cables a

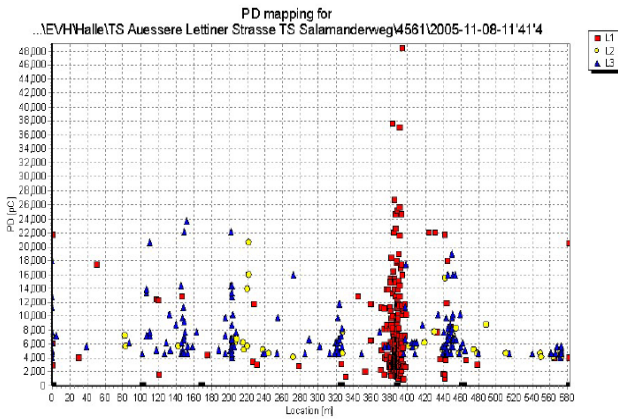
Figure 6: PD in paper insulation nearby a dry joint due to leaking

Mappings of PILC cables often show a “Christmas tree-like” distribution of the PD locations (figure 6).

In this case the joint loses its oil filling due to a leakage and the paper insulation nearby the joint is drying out.

While in PILC scattered PD locations in the paper insulation are quite normal and not dangerous (figure 5 and 6) in XLPE cables in the insulation normally no PD is to be observed. In XLPE cables PD faults are mainly caused by bad workmanship at joints and terminations. In figure 9 It can clearly be seen that in the set of joints at 200 m in conductor 1 and at 360 m in conductors 2 and 3, PD with high intensity very often occur. This test object is a 20 kV XLPE cable system with poorly mounted heat-shrink joints. Remarkably these extremely bad mounted joints with very high PD levels did not lead to a failure of the joints until 5 to 6 years of operation (figure 10). In the last 5 years lots of similar assembly defects were detected and located by OWTS technology.
